# SUMMARY REPORT

# CITY OF ESCANABA

# OGDEN TRIANGLE HISTORIC RESOURCE INVENTORY

Prepared for the City of Escanaba  
April 2023

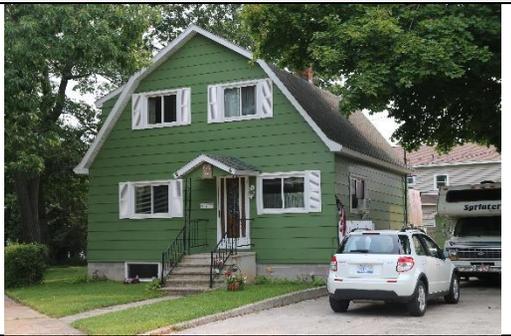
#	Address	Date	Comments	Status	Photo
1	103 1 <sup>st</sup> Ave S	c. 1925	Overall form and massing are generally consistent; replacement siding throughout house; shingles at dormer; replacement sliding sash windows, replacement door	NC

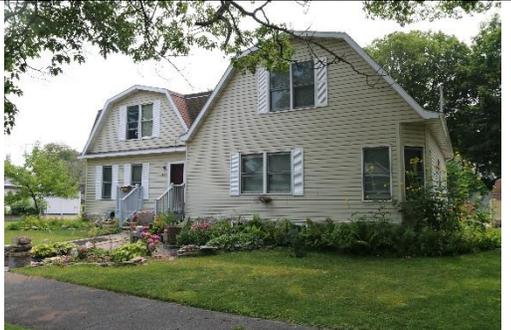
2	127 1 <sup>st</sup> Ave S	c. 1890	Massing generally consistent. Vinyl siding throughout house; replacement windows, replacement doors; replacement porch	NC

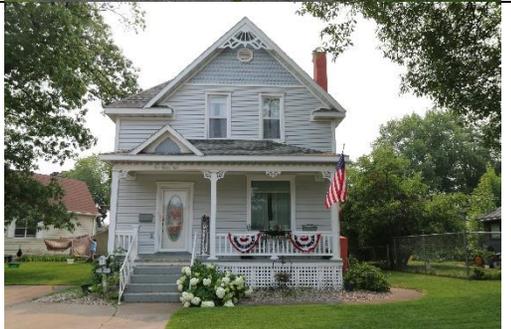
3	131 1 <sup>st</sup> Ave S	c. 1900	Overall form and massing are generally consistent. Vinyl siding and wood elements throughout. Decorative elements at porch include dentils, posts, scrollwork; vergeboard at gable	C

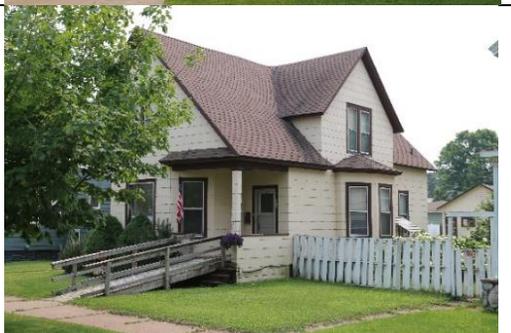
4	307 1 <sup>st</sup> Ave S	c. 1905	Overall form and massing are generally consistent. Asbestos shingle siding; some replacement windows	C

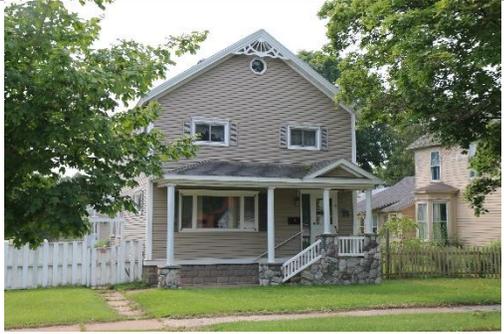
#	Address	Date	Comments	Status	Photo
5	311 1 <sup>st</sup> Ave S	c. 1895	Replacement siding throughout house; replaced and altered window openings; full-length porch removed; entry configuration altered	NC

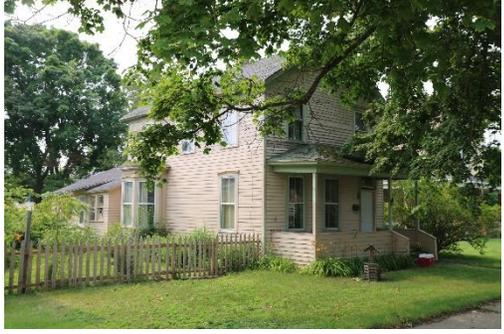
6	317 1 <sup>st</sup> Ave S	c. 1885	Overall massing and form intact. Clapboard siding, shingles, wood windows, and trim intact; minor alterations	C

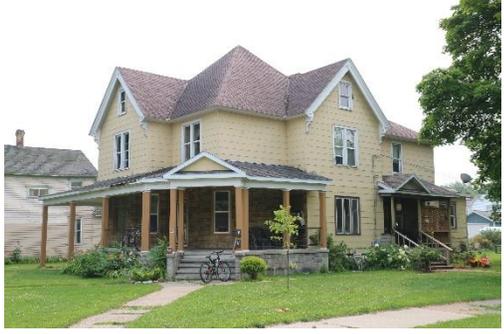
7	321 1 <sup>st</sup> Ave S	c. 1900	Massing and form generally intact; asbestos shingles throughout house; Porches generally reflect historic configuration but new materials and slight modifications; first floor veneered at porch; combination of wood and replacement windows	NC

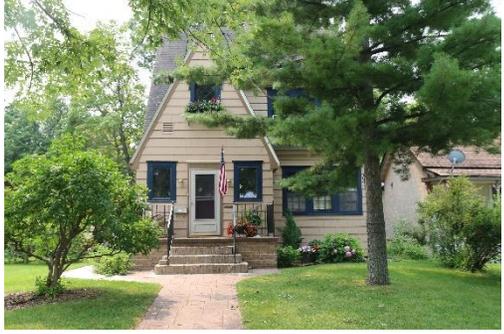
8	407 1 <sup>st</sup> Ave S	c. 1920	Overall massing and form intact; wood shingles throughout; wood windows, door, and decorative elements present; decorative chimneys intact	C

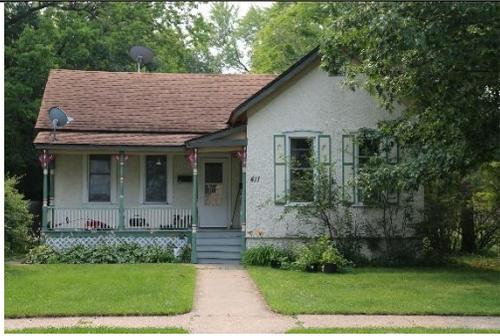
#	Address	Date	Comments	Status	Photo
9	411 1 <sup>st</sup> Ave S	c. 1880	Form and massing generally intact; stucco cladding (originally clapboard); partial-width porch with turned posts; replaced balustrade; wood windows	C

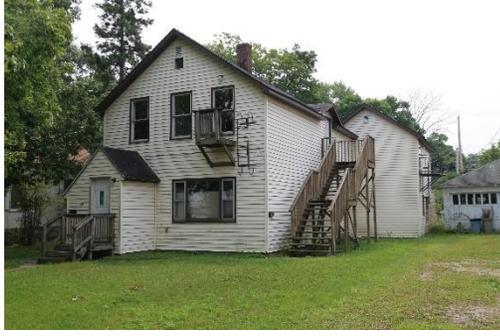
10	415 1 <sup>st</sup> Ave S	c. 1900	Massing and form altered through additions and enclosures; vinyl throughout the house; replaced and altered window sizes and configurations; front entry configuration modified	NC

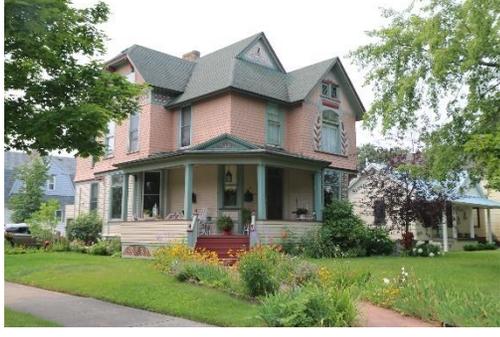
11	501 1 <sup>st</sup> Ave S	c. 1895	Overall form and massing intact; wood shingle, wood trim, wood decorative elements, and wood windows present; porch retains historic configuration and design elements	C

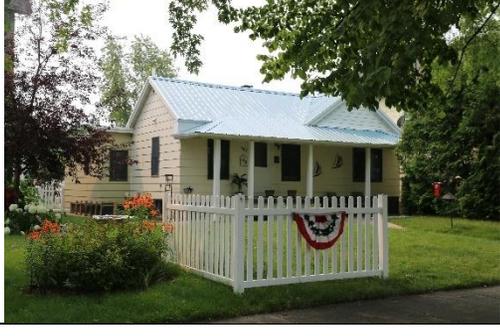
12	507 1 <sup>st</sup> Ave S	c. 1910	Massing and form generally intact; aluminum siding and window replacements throughout house; metal replacement roof	NC

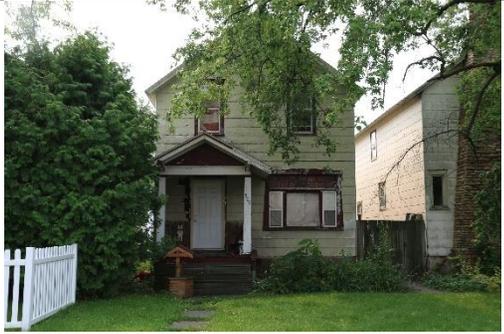
#	Address	Date	Comments	Status	Photo
13	509 1 <sup>st</sup> Ave S	c. 1910	Overall form and massing generally intact; Asbestos shingles throughout house; wood windows; replacement door	C

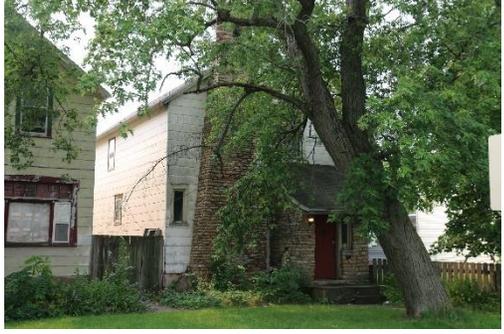
14	511 1 <sup>st</sup> Ave S	c. 1910	Form and massing generally intact; asbestos shingle; wood window; decorative brick and stone chimney added at unknown point, originally full-width porch	NC

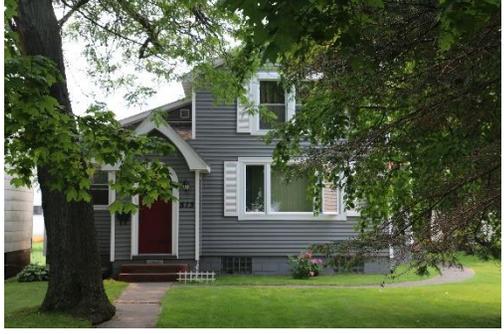
15	513 1 <sup>st</sup> Ave S	c. 1900	Altered form and massing; replacement siding throughout house; replacement windows; front porch removed	NC

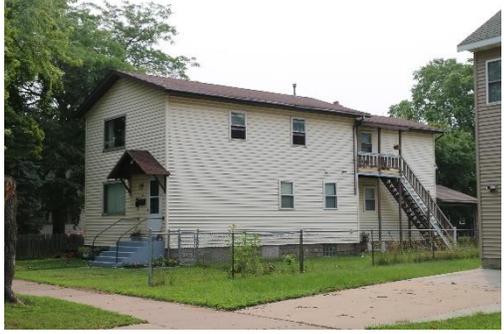
16	517 1 <sup>st</sup> Ave S	c. 1900	Form altered, but multiple additions historically present based on Sanborn. Replacement siding throughout; replaced and altered window sizes; altered entry configuration	NC

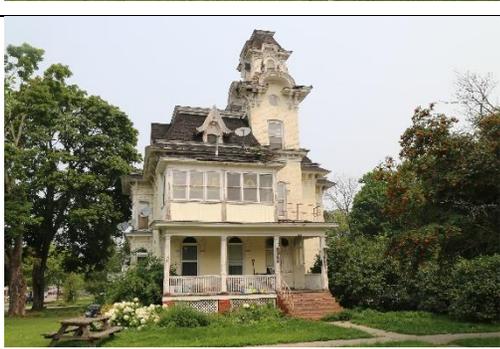
27	420 2 <sup>nd</sup> Ave S	c. 1865	Original form and massing generally intact; enclosed second-story veranda; original detailing remains throughout; scattered window replacement but fenestration remains intact	C

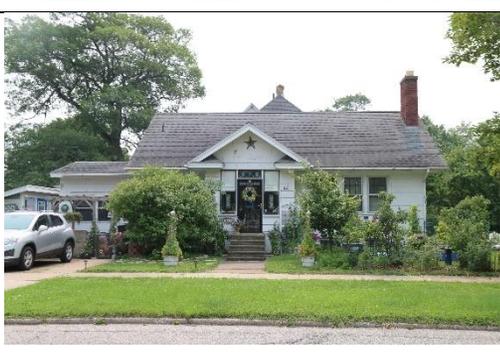
28	421 2 <sup>nd</sup> Ave S	c. 1930	Form and massing are generally intact; scattered window and door replacement.	C

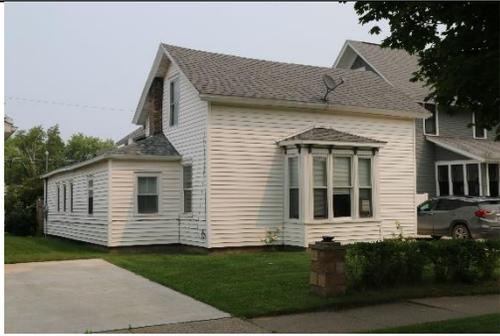
#	Address	Date	Comments	Status	Photo
29	508 2 <sup>nd</sup> Ave S	c. 1895	Replacement siding throughout house; some replacement windows; chimney cut off at roofline; wraparound porch on side replaced with stoop; front bay added post-1920 based on Sanborn	NC

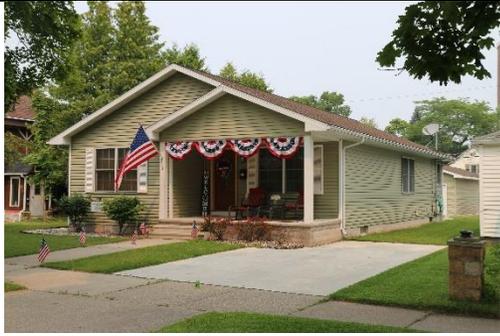
30	510 2 <sup>nd</sup> Ave S	c. 2000	New construction	NC

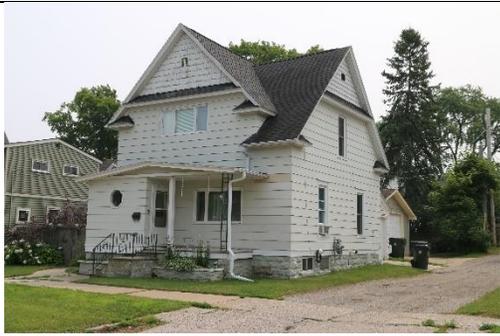
31	511 2 <sup>nd</sup> Ave S	c. 1890	Original massing and form generally intact; replacement siding throughout house; porch configuration altered; some replacement windows, including altered sizes; replacement doors/altered entry configuration	NC

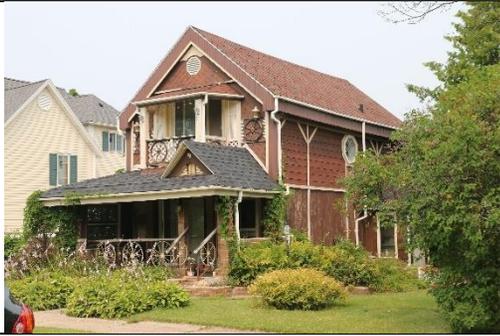
32	514 2 <sup>nd</sup> Ave S	c. 1890	Original massing and form altered with addition of noncompatible porch and second-floor balcony; replacement siding materials, fascia boards, and windows, including altered openings in some locations	NC

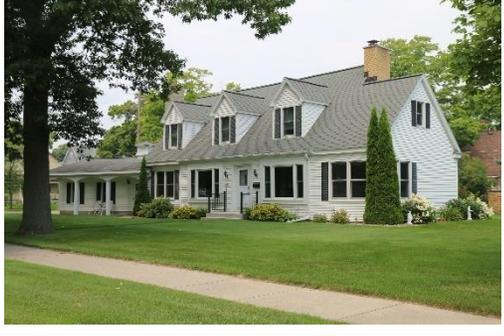
40	620 5 <sup>th</sup> Ave S	c. 1945	Form and massing generally intact; replacement siding; replacement windows; altered entry configuration; replacement porch; replacement door	C

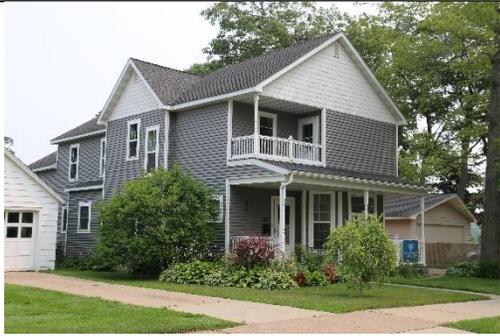
#	Address	Date	Comments	Status	Photo
49	319 S 3 <sup>rd</sup> St	c. 1900	Original form altered; fenestration altered at second story; replacement siding throughout; replacement windows and doors; replacement porch components.	NC

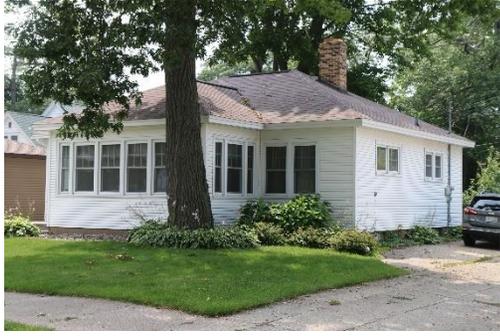
50	320 S 3 <sup>rd</sup> St	c. 1940	Form and massing intact; replacement siding; replacement windows	C

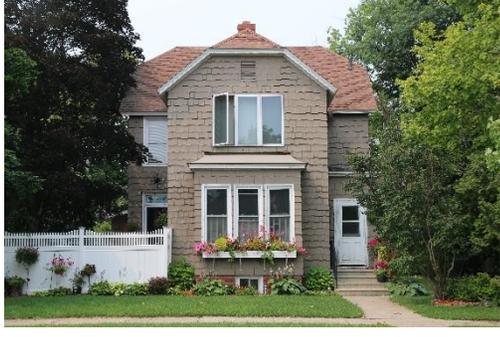
51	208 S 4 <sup>th</sup> St	c. 1880	Original massing and form generally intact; wood shingle cladding; replacement windows throughout.	C

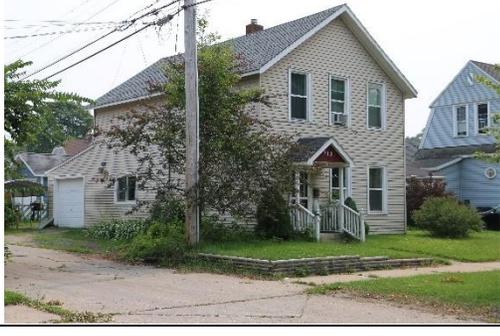
52	213 S 4 <sup>th</sup> St	c. 1890	Form and massing generally intact, historic addition converted; replacement siding; combination of historic and replacement windows; altered window on side; porch hood/porch added	NC

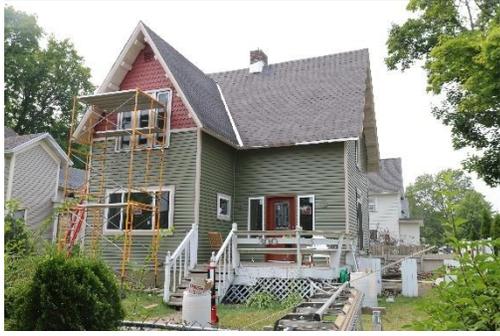
62	300 S 5 <sup>th</sup> St	c. 1900	Addition at rear; replacement siding; replacement windows throughout/altered openings; replacement entry	NC

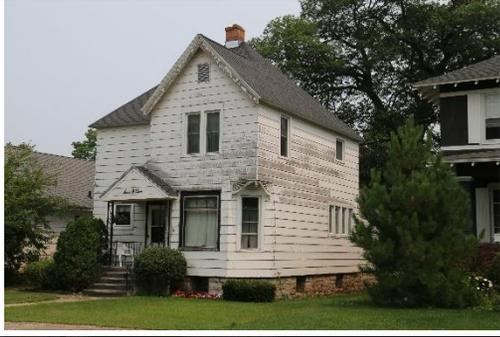
63	305 S 5 <sup>th</sup> St	c. 1890	Form and massing generally intact; Masonite siding; combination of original and replacement windows; chamfered bays with decorative scrollwork; front posts replaced	C

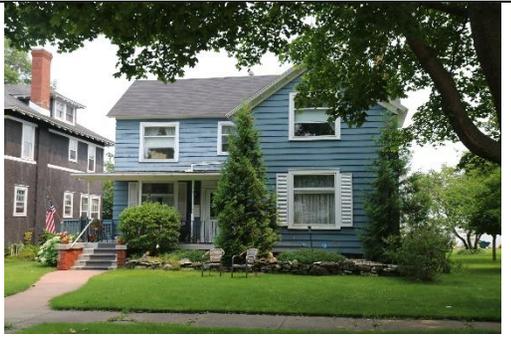
66	315 S 5 <sup>th</sup> St	c. 1925	Form and massing generally intact; lap siding; full-width porch; columns and balustrade replaced; combination of historic and replacement windows; rusticated foundation block	C

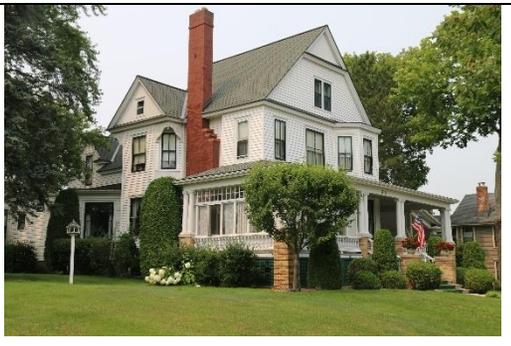
67	316 S 5 <sup>th</sup> St	c. 1890	Form and massing generally intact; clapboard siding; wood windows throughout; wraparound porch with paired columns and decorative balustrade	C

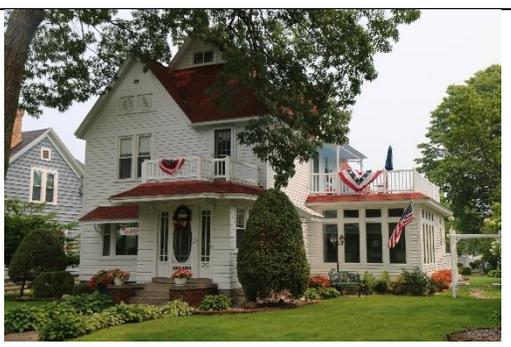
68	319 S 5 <sup>th</sup> St	c. 1885	Form and massing generally intact, addition at side; combination of historic and replacement windows; single-leaf entry with sidelights; rusticated foundation	C

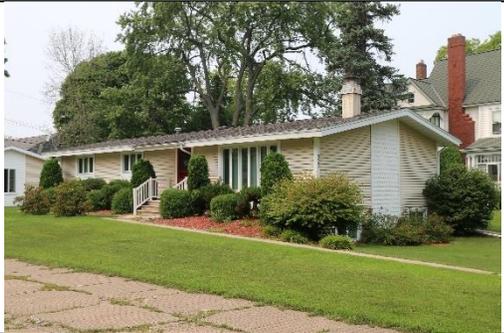
#	Address	Date	Comments	Status	Photo
69	322 S 5 <sup>th</sup> St	c. 1980	Outside period of significance	NC

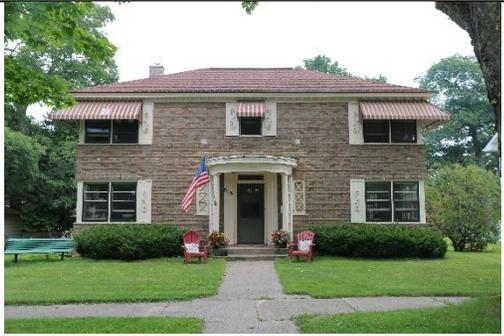
#	Address	Date	Comments	Status	Photo
73	515 S 5 <sup>th</sup> St	c. 1940	Form and massing intact; historic windows; brick veneer with decorative beltcourse; dentiled eave; single-leaf entry with transom and pilasters	C

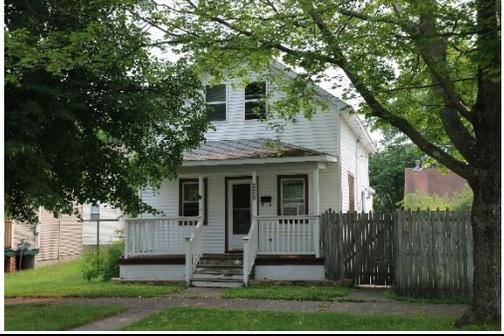
74	209 S 6 <sup>th</sup> St	c. 1895	Form and massing intact; replacement siding; replacement windows; full-width porch	C

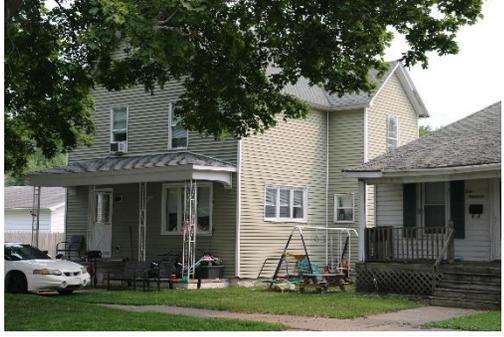
75	215 S 6 <sup>th</sup> St	c. 1890	Form and massing intact; replacement siding; replacement windows; some altered window openings; full-width porch with replacement posts	NC

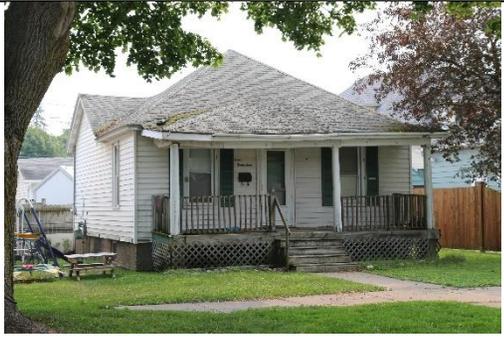
76	217 S 6 <sup>th</sup> St	c. 1895	Form and massing generally intact, side enclosure; historic windows; replacement siding; full-width porch with replacement balustrade; parged foundation	C

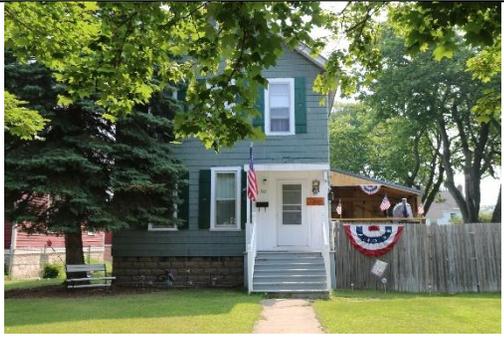
96	313 S 7 <sup>th</sup> St	c. 1885	Form and massing generally intact, side addition; rusticated foundation; asbestos siding; historic windows; replacement entry and siding in incised porch	C

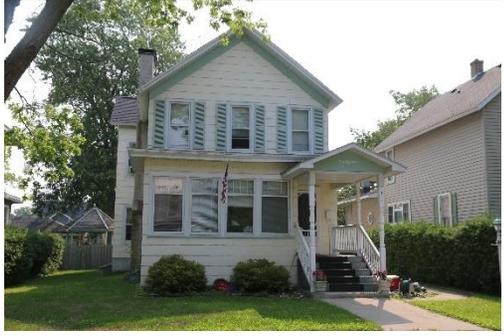
102	407 S 7 <sup>th</sup> St	c. 1900	Form and massing generally intact; front porch altered, but historic; wood windows throughout; asbestos siding; chimney parged	C

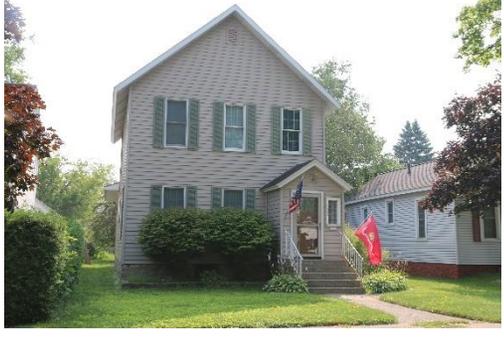
103	409 S 7 <sup>th</sup> St	c. 1900	Form and massing generally intact, but porch enclosed; replacement siding; combination of historic and replacement windows	NC

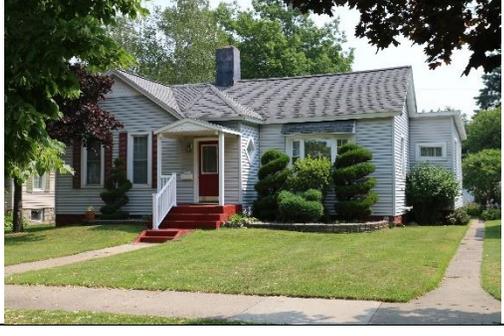
104	413 S 7 <sup>th</sup> St	c. 1900	Form and massing altered; replacement siding; replacement windows; replacement door; altered widow configuration; replaced porch elements	NC

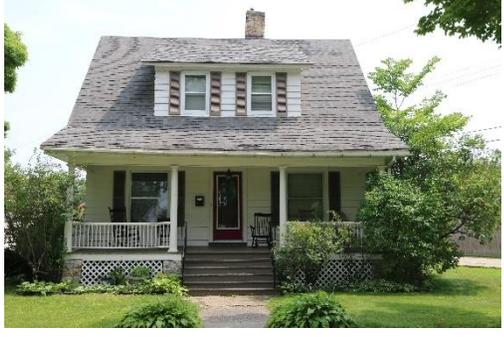
110	521 S 7 <sup>th</sup> St	c. 1915	Form and massing generally intact; lap siding; wood windows; full-width porch with columns	C

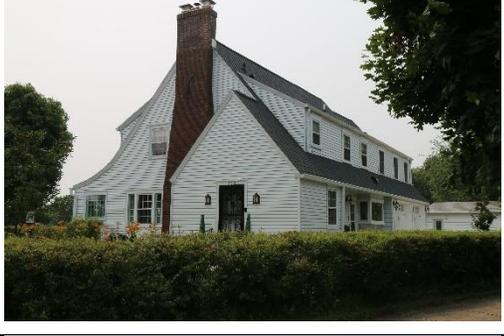
111	200 Lake Shore Dr	c. 1925	Form and massing altered through addition of second story/reconfiguration at western end; dormers extended; replacement siding; combination of replacement and historic windows; rear configuration significantly altered	NC

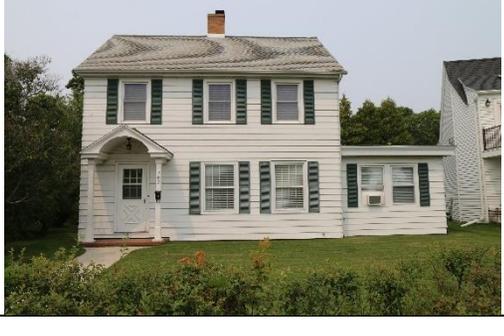
112	202 Lake Shore Dr	c. 1920	Form and massing generally intact, historic side addition; replacement siding; historic windows; porch with pedimented hood and posts; entry configuration altered; fanlight enclosed	C

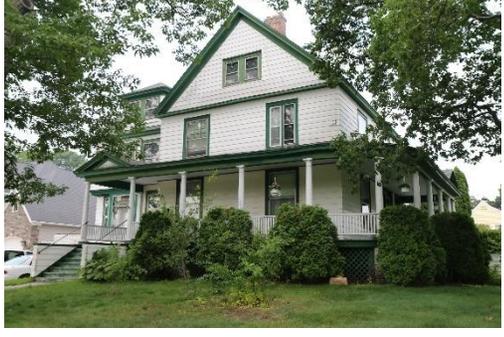
130	404 Lake Shore Dr	c. 1885	Form and massing generally intact; replacement siding; historic windows; wraparound porch with columns and dentiled pediments	C

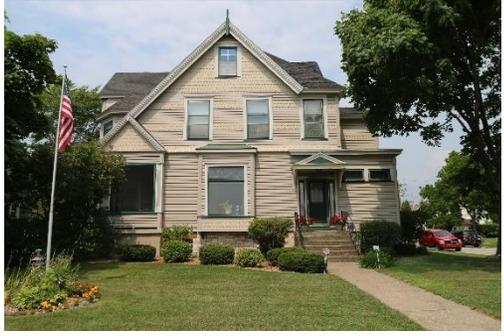
138	600 Lake Shore Dr	c. 1895	Form and massing generally intact, porch historically enclosed; clapboard and scalloped siding; wood windows; pedimented entry hood; single-leaf entry with sidelights and transom	C

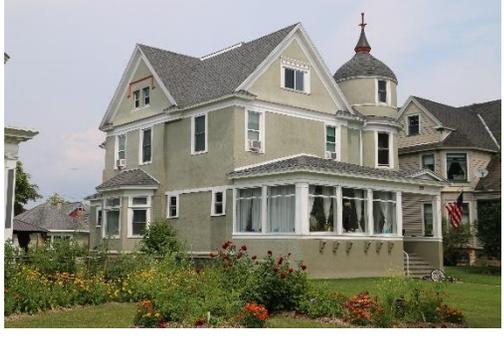
139	602 Lake Shore Dr	c. 1890	Form and massing generally intact; gable added to full-width front porch; porch partially enclosed, posts remain evident; combination of historic and replacement windows; finial at tower	C

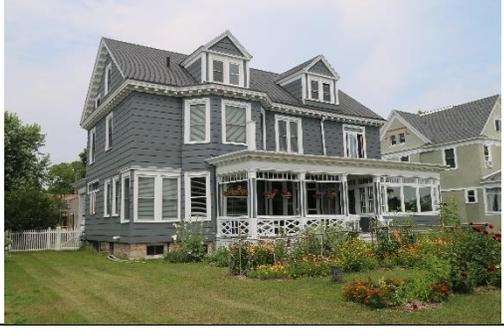
140	610 Lake Shore Dr	c. 1900	Form and massing generally intact; ¾-width front porch partially enclosed; paneled posts remain; replacement windows; replacement siding; altered opening at second story; bracketed cornice	C
