# City of Escanaba Wastewater System Improvements

Michigan Clean Water State Revolving Fund Project Plan (2023)  
Volume 2 – Appendix (FINAL)

22-0290

April 26, 2023

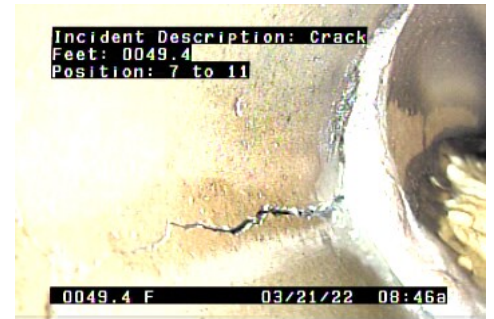
C - Crack @ 49.9 ft.

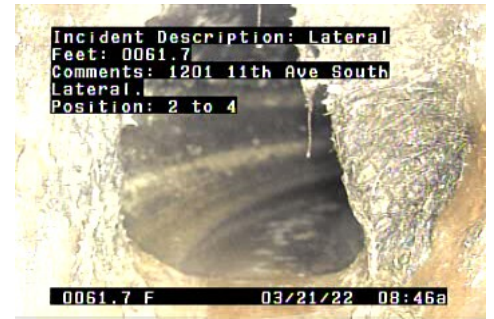
L - Lateral @ 61.7 ft. 1201 11th Ave South Lateral.

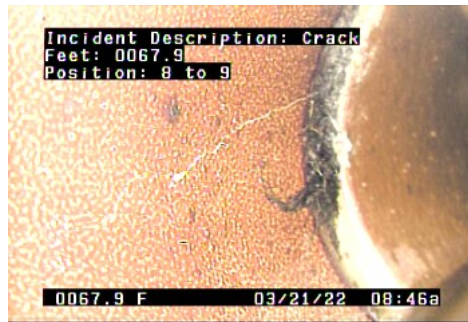
C - Crack @ 67.9 ft.

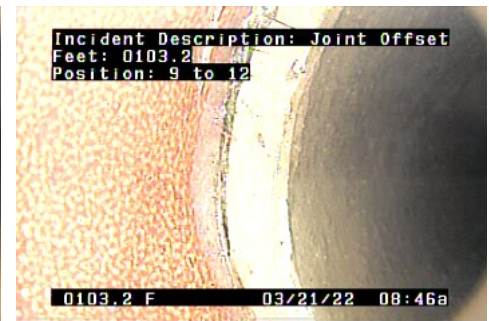
JO - Joint Offset @ 103.2 ft.

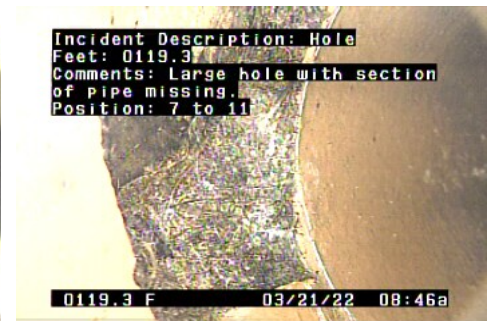
H - Hole @ 119.3 ft. Large hole with section of pipe missing.

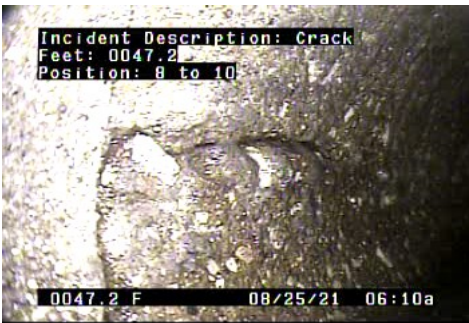
C - Crack @ 47.2 ft.

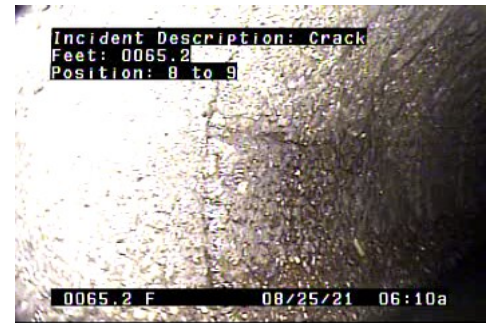
C - Crack @ 65.2 ft.

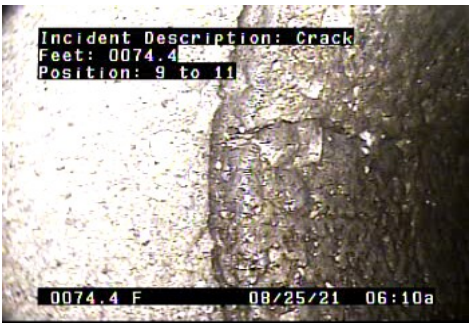
C - Crack @ 74.4 ft.

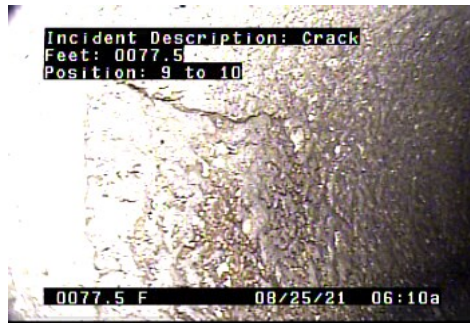
C - Crack @ 77.5 ft.

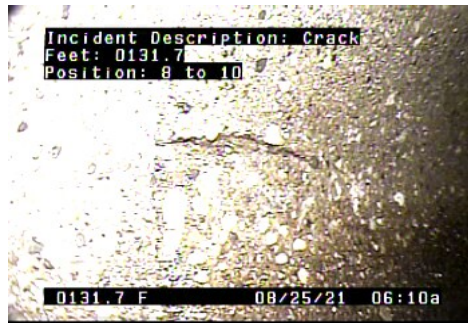
C - Crack @ 131.7 ft.

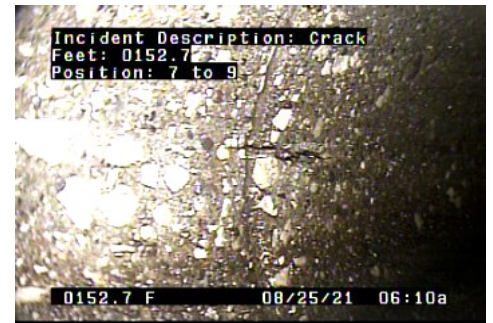
C - Crack @ 152.7 ft.

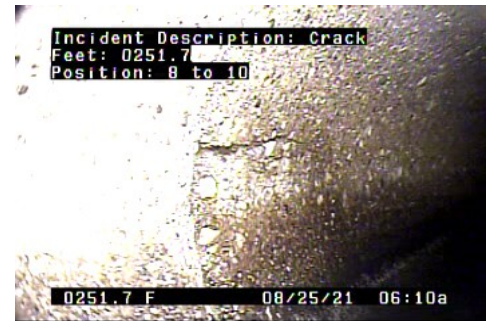
C - Crack @ 251.7 ft.

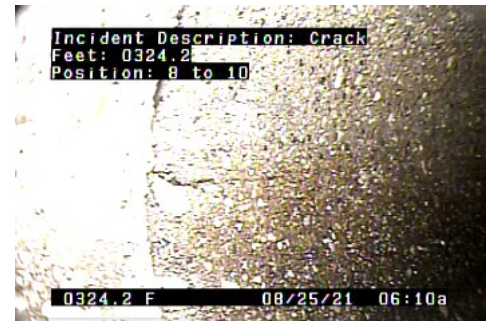
C - Crack @ 324.2 ft.

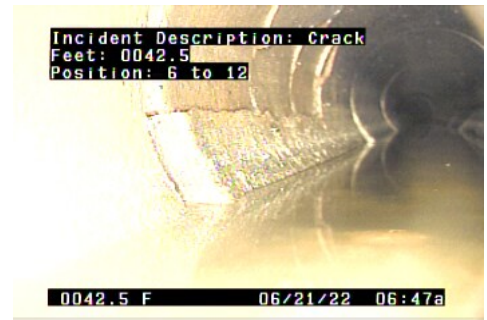
C - Crack @ 42.5 ft.

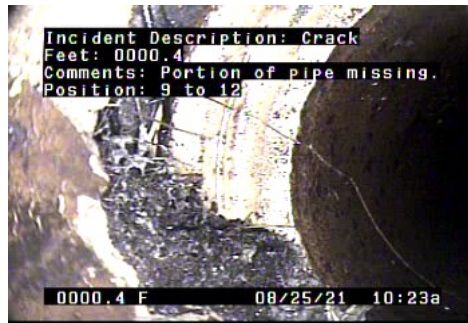
C - Crack @ 0.4 ft. Portion of pipe missing.

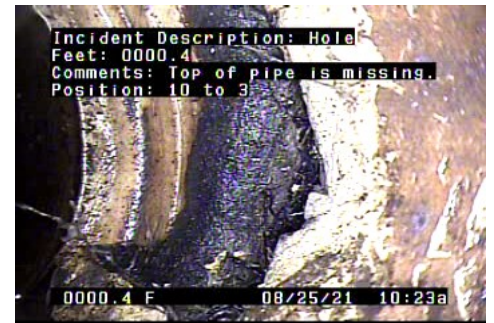
H - Hole @ 0.4 ft. Top of pipe is missing.

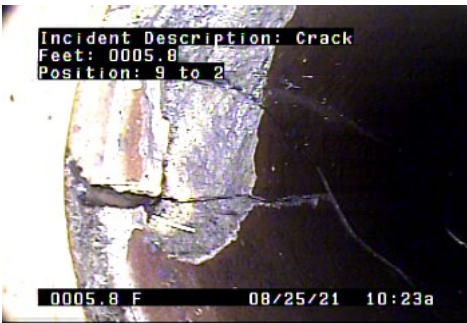
C - Crack @ 5.8 ft.

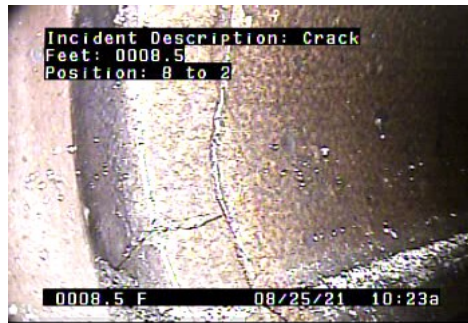
C - Crack @ 8.5 ft.

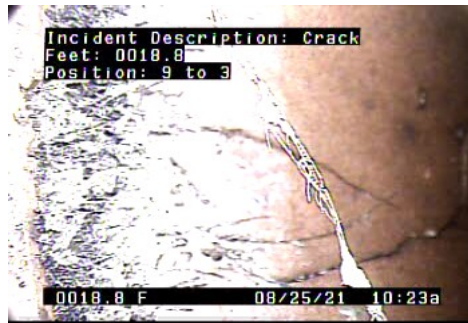
C - Crack @ 18.8 ft.

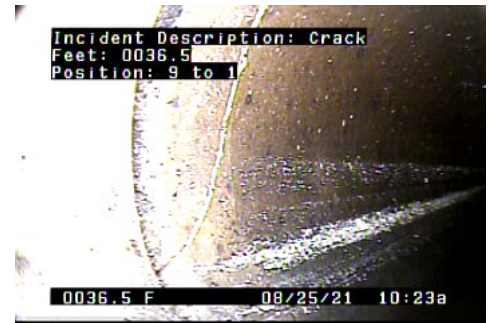
C - Crack @ 36.5 ft.

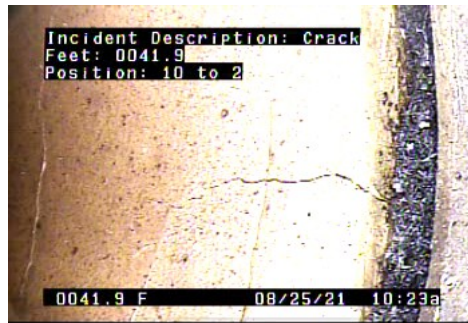
C - Crack @ 41.9 ft.

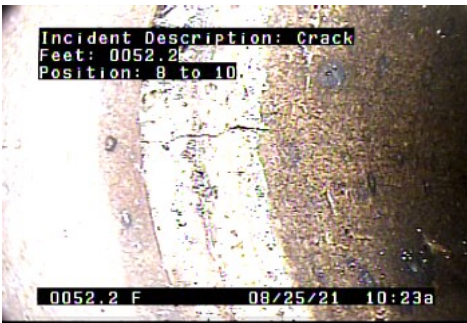
C - Crack @ 52.2 ft.

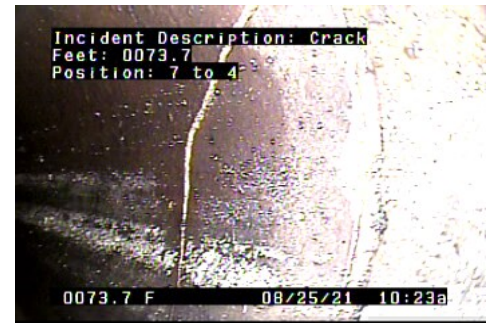
C - Crack @ 73.7 ft.

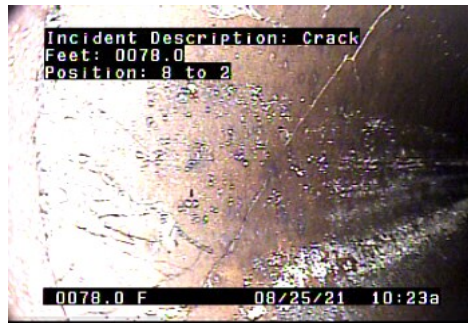
C - Crack @ 78.0 ft.

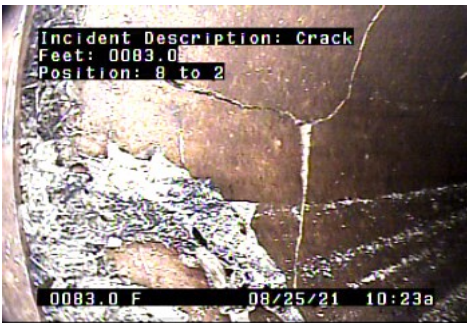
C - Crack @ 83.0 ft.

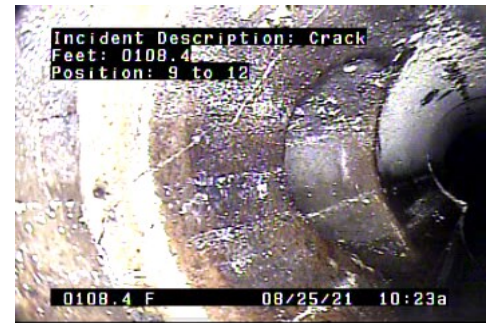
C - Crack @ 108.4 ft.

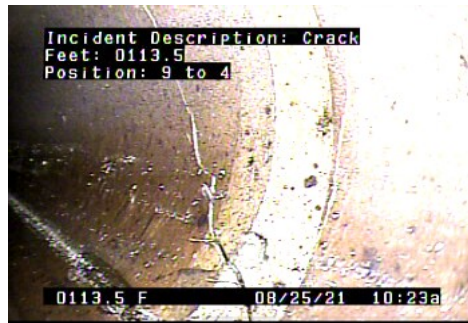
C - Crack @ 113.5 ft.

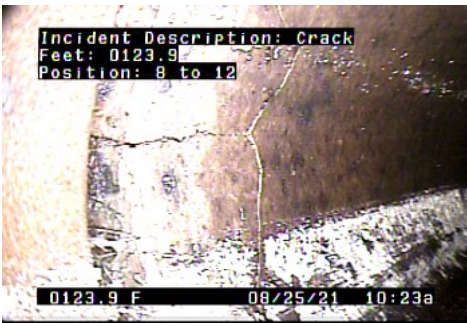
C - Crack @ 123.9 ft.

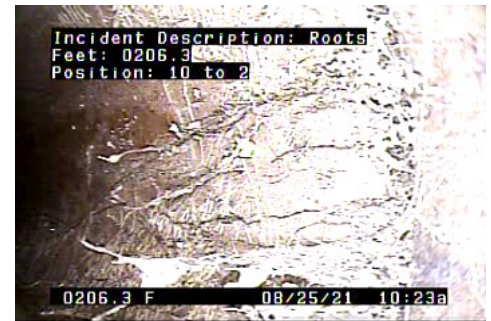
R - Roots @ 206.3 ft.

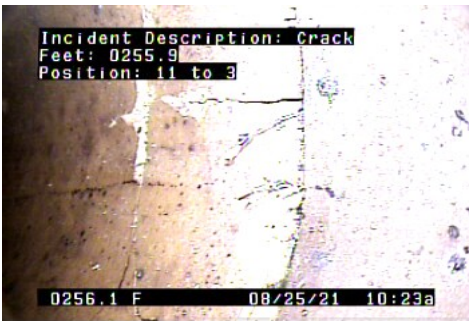
C - Crack @ 255.9 ft.

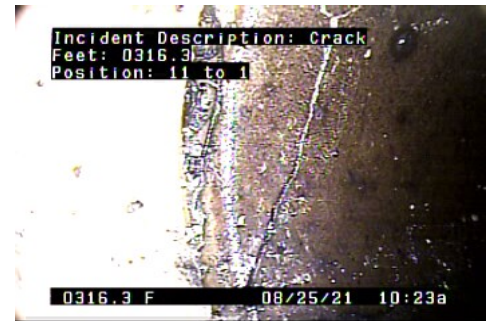
C - Crack @ 316.3 ft.

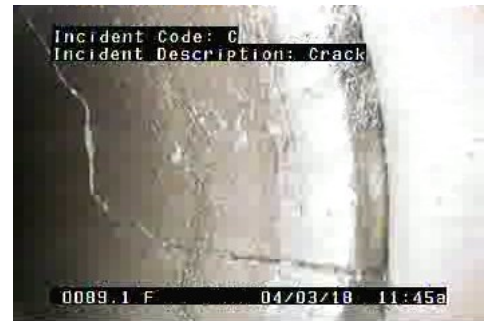
C - Crack @ 89.1 ft.

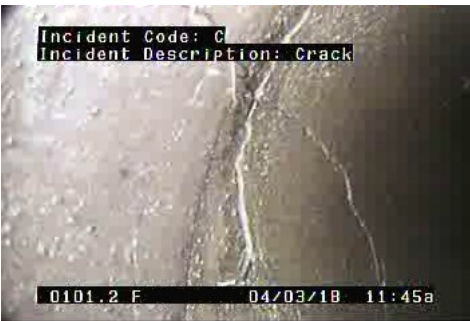
C - Crack @ 101.2 ft.

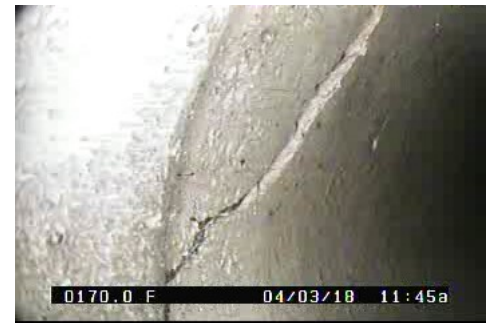
C - Crack @ 170.0 ft.

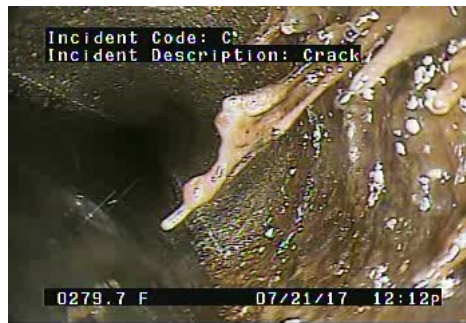
C - Crack @ 279.7 ft.

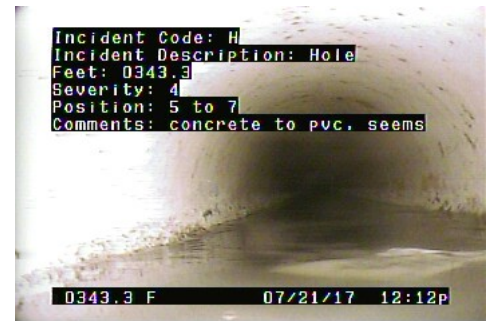
H - Hole @ 343.3 ft. concrete to pvc, seems to be hole on bottom

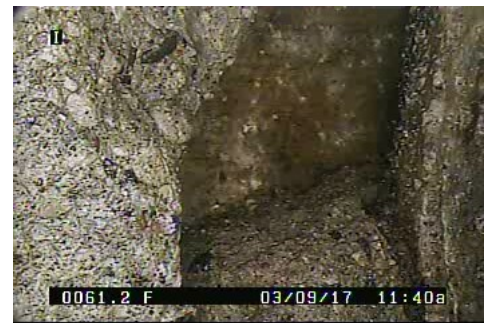
C - Crack @ 61.2 ft. wide crack possible exposed ground

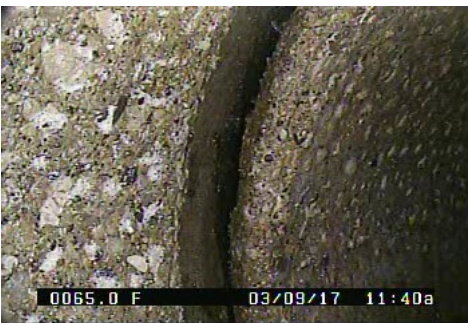
JS - Joint Separated @ 65.0 ft.

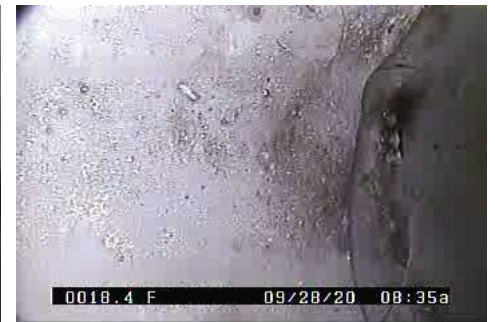
C - Crack @ 18.4 ft.

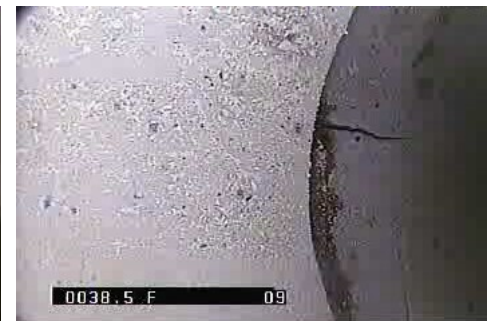
C - Crack @ 38.5 ft.

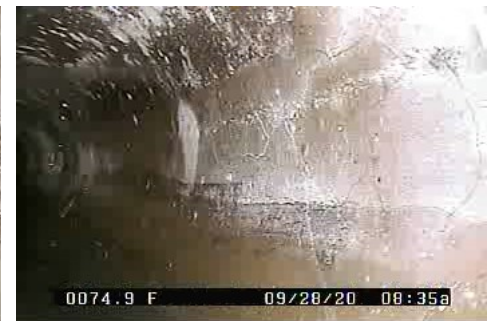
C - Crack @ 74.9 ft.

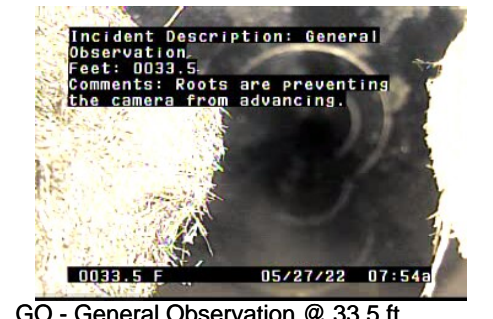
GO - General Observation @ 33.5 ft. Roots are preventing the camera from advancing.
