# SUMMARY REPORT

# CITY OF ESCANABA

# OGDEN TRIANGLE HISTORIC RESOURCE INVENTORY

Prepared for the City of Escanaba  
April 2023

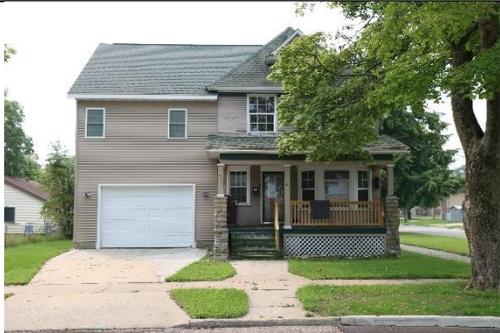
18	306 2 <sup>nd</sup> Ave S	c. 1900	Form and massing generally intact; replacement siding; replacement windows; some window configuration alteration; entry alteration; new porch	NC

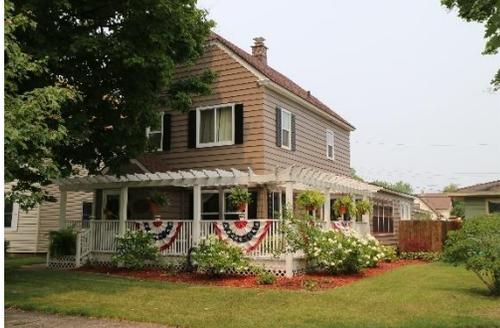
19	308 2 <sup>nd</sup> Ave S	c. 1900	Massing and form generally intact; replaced and altered window sizes; door alteration; replacement siding throughout house; full-length porch removed; decorative elements likely removed	NC

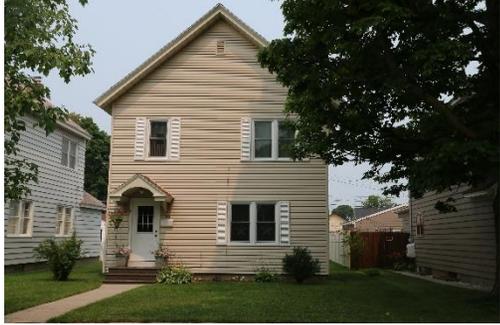
20	310 2 <sup>nd</sup> Ave S	c. 1890	Massing and form generally intact; altered window profiles; door alteration; replacement siding throughout house; full-length porch removed; decorative elements likely removed	NC

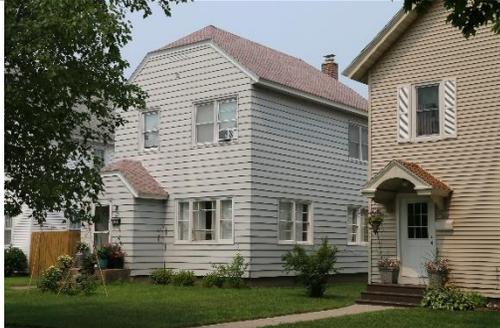
#	Address	Date	Comments	Status	Photo
21	316 2 <sup>nd</sup> Ave S	c. 1900	Massing and form generally intact; replacement windows; door alteration; replacement siding throughout house; full-length porch removed; decorative elements likely removed	NC

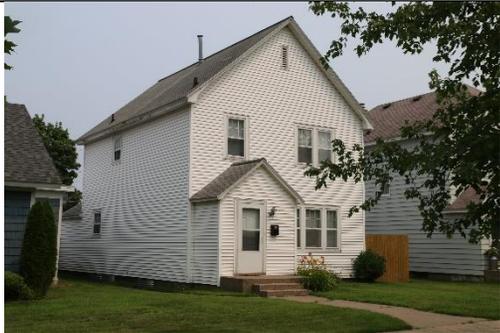
22	318 2 <sup>nd</sup> Ave S	c. 1910	Form and massing intact, historic additions; replacement siding; replacement windows; altered porch; replacement door	NC

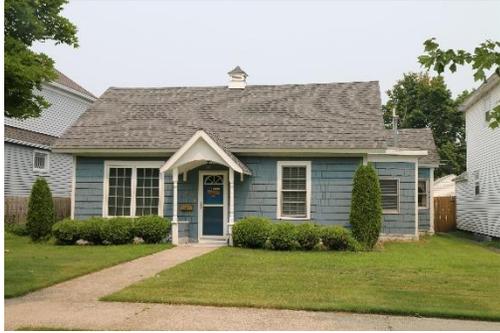
23	322 2 <sup>nd</sup> Ave S	c. 1900	Original form and massing intact; retains historic front porch; replacement siding throughout; some window replacement but openings intact; front door replacement	C

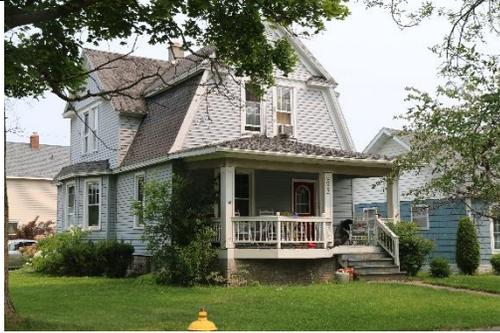
24	410 2 <sup>nd</sup> Ave S	c. 1905	Form and massing generally intact; replacement siding throughout house; replacement windows throughout house, bay window added, replacement sidelights, modified fenestration with addition of sliding doors; single-bay hood replaced full-width porch; replacement columns on existing porch	NC

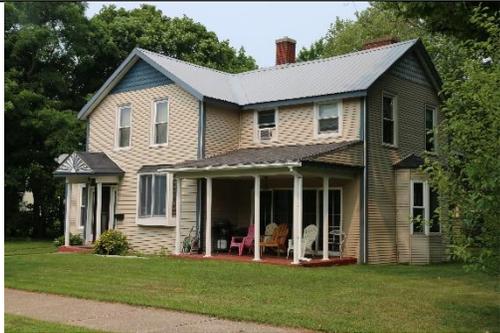
#	Address	Date	Comments	Status	Photo
25	411 2 <sup>nd</sup> Ave S	c. 1910	Massing and form generally intact, although wraparound porch has been removed; replacement siding throughout house; replacement windows; some window alteration.	NC

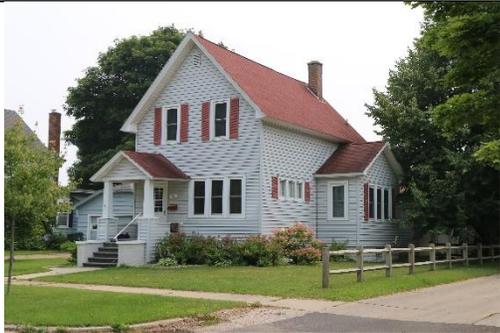
26	415 2 <sup>nd</sup> Ave S	c. 1900	Massing and form generally intact, although wraparound porch has been removed; replacement siding throughout; replaced door; combination of historic and replacement windows; porch elements replaced	NC

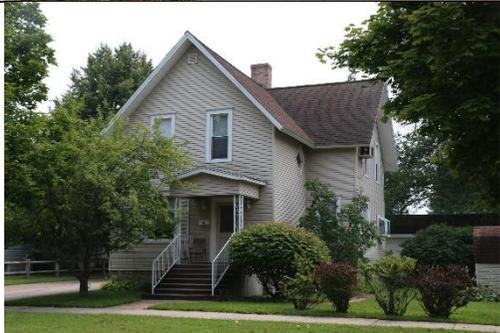
27	420 2 <sup>nd</sup> Ave S	c. 1865	Original form and massing generally intact; enclosed second-story veranda; original detailing remains throughout; scattered window replacement but fenestration remains intact	C

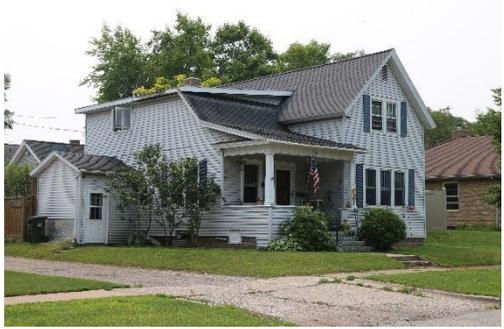
34	516 2 <sup>nd</sup> Ave S	c. 1900	Form and massing generally intact, historic addition; replacement siding; replacement windows; replacement door; rusticated foundation; some replacement porch elements	NC

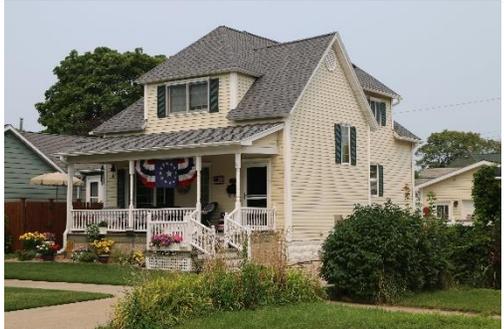
35	522 2 <sup>nd</sup> Ave S	c. 1910	Form and massing generally intact, historic addition/rear porch enclosure; replacement siding; replacement door; combination of historic and replacement windows; rusticated foundation	C

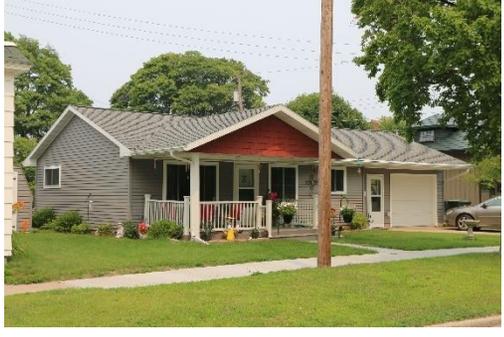
40	620 5 <sup>th</sup> Ave S	c. 1945	Form and massing generally intact; replacement siding; replacement windows; altered entry configuration; replacement porch; replacement door	C

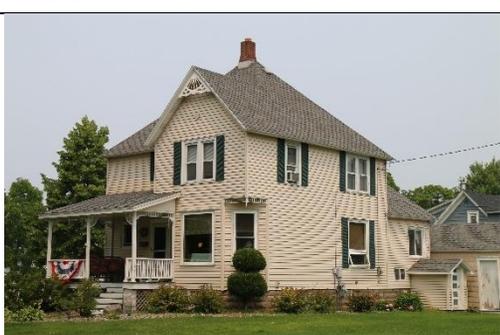
#	Address	Date	Comments	Status	Photo
45	309 S 3 <sup>rd</sup> St	c. 1890	Multiple historic additions at rear; front porch enclosed and roofline altered; Masonite cladding; mix of historic and replacement windows, at least a couple of openings altered.	C

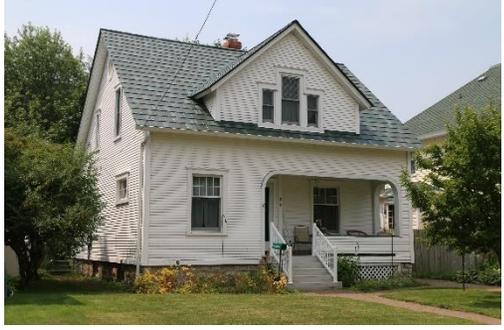
47	315 S 3 <sup>rd</sup> St	c. 1900	Original form and massing generally intact; combination of historic and replacement windows; replacement siding throughout; replacement components at front porch	C

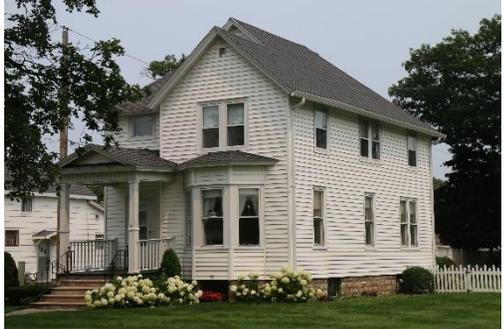
48	316 S 3 <sup>rd</sup> St	c. 1910	Original form and massing generally intact; replacement siding throughout; replacement windows.	C

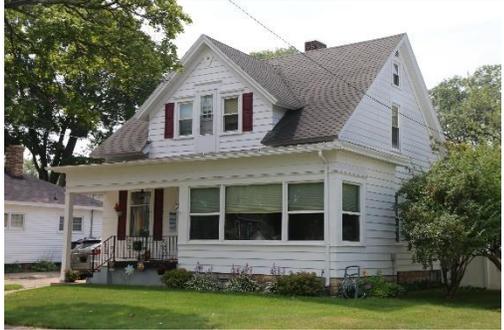
#	Address	Date	Comments	Status	Photo
49	319 S 3 <sup>rd</sup> St	c. 1900	Original form altered; fenestration altered at second story; replacement siding throughout; replacement windows and doors; replacement porch components.	NC

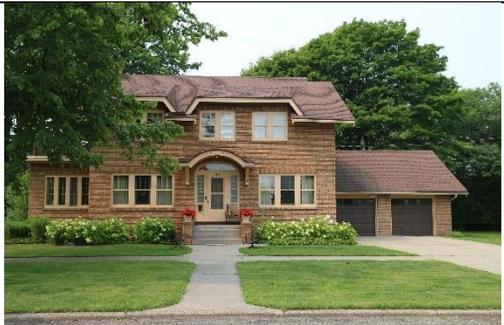
54	312 S 4 <sup>th</sup> St	c. 1910	Original form and massing intact; clapboard siding; original windows throughout; flared eave with brackets; original entry door; full-width porch with battered posts on wall.	C

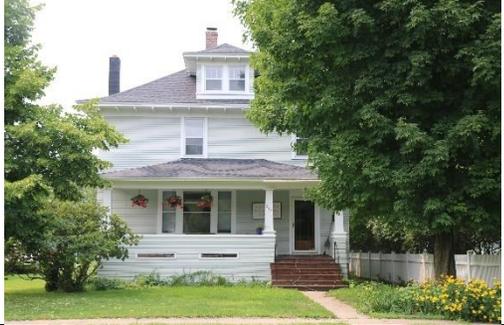
55	406 S 4 <sup>th</sup> St	c. 1925	Original form and massing intact; front entry stoop enclosed; replacement windows throughout; combination clapboard and drop siding.	C

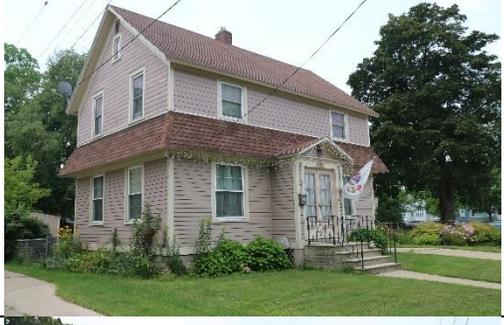
56	408 S 4 <sup>th</sup> St	c. 1935	Original form and massing intact; wood lap siding; original windows; decorative hoods at first story; portico with columns, multi-light door, and pilasters.	C

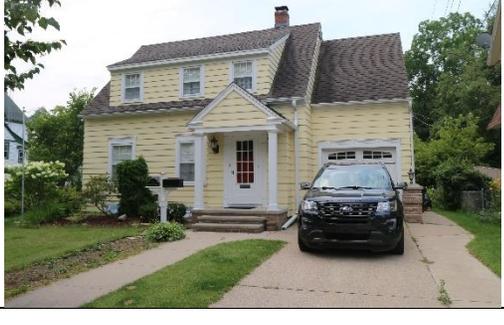
57	201 S 5 <sup>th</sup> St	c. 1885	Original form and massing generally intact; historic additions; enclosure added at side of front porch; stucco cladding (originally clapboard); combination of historic and replacement windows; decorative porch columns and balustrade intact	C

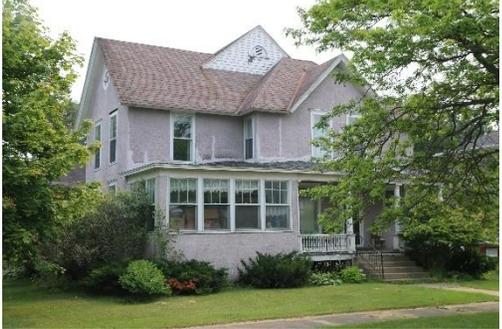
58	210 S 5 <sup>th</sup> St	c. 1900	Original form and massing intact; combination of Masonite siding and wood shingle; combination of historic and replacement windows	C

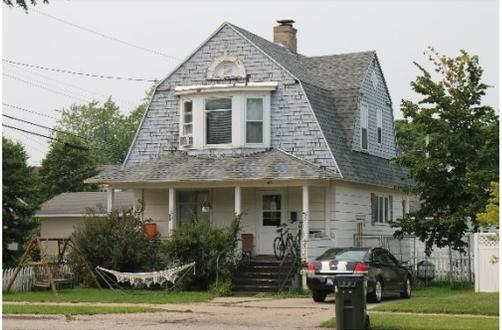
59	211 S 5 <sup>th</sup> St	c. 1920	Original form and massing intact; replacement siding; original windows intact; porch hood form generally intact; single-leaf entry with sidelights and transom	C

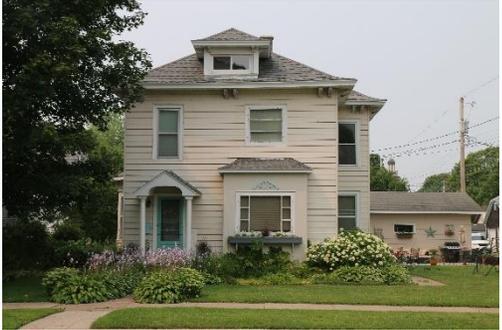
60	216 S 5 <sup>th</sup> St	c. 1900	Original form and massing generally intact; replacement siding; combination of original and replacement windows; bay window modified; replacement porch (originally wraparound); brackets at eave	NC

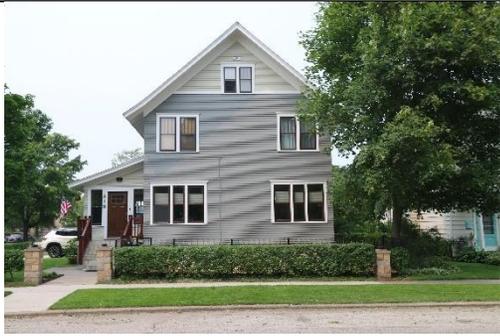
#	Address	Date	Comments	Status	Photo
61	218 S 5 <sup>th</sup> St	c. 1900	Form and massing generally intact; wood windows and openings intact; clapboard siding; exposed rafter tails at eave; front stoop rebuilt	C

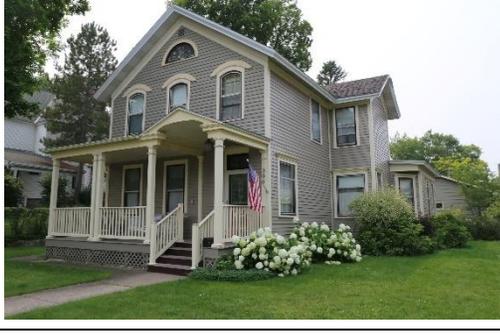
64	306 S 5 <sup>th</sup> St	c. 1885	Form and massing generally intact; clapboard siding; wood windows with decorative hoods; single-leaf entry with transom; full-width porch with posts and balustrade	C

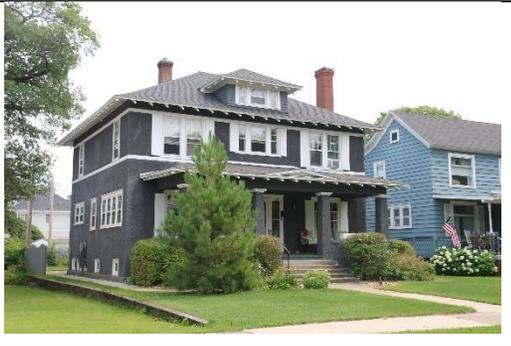
#	Address	Date	Comments	Status	Photo
65	309 S 5 <sup>th</sup> St	c. 1915	Form and massing intact; stucco finish; beltcourse at second floor; wood windows; single-leaf entry with sidelights; exposed rafter tails at flared eave; full-width porch with battered columns	C

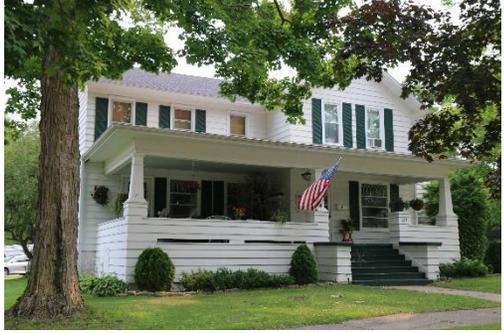
70	327 S 5 <sup>th</sup> St	c. 1890	Form and massing generally intact; replacement siding; combination of historic and replacement windows; full-width porch with battered posts; decorative window lacing at first story; rusticated foundation	C

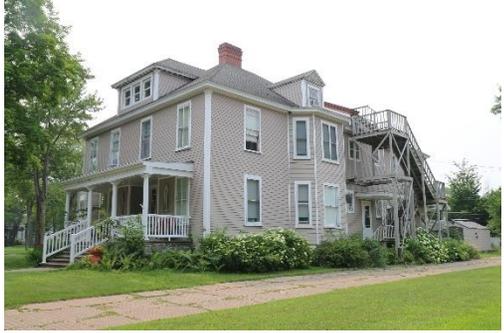
71	328 S 5 <sup>th</sup> St	c. 1900	Form and massing generally intact, historic additions at rear; clapboard siding; wood windows throughout most of house, but some replacement; full-width front porch with columns; single-leaf entry with sidelights; rusticated foundation	C

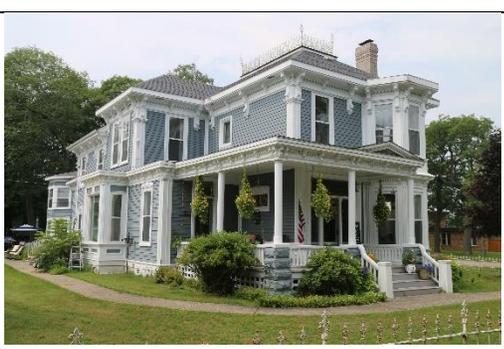
72	504 S 5 <sup>th</sup> St	1881	Form and massing generally intact, historic additions at rear; garage at rear; single-leaf entry with sidelights and transom; wraparound porch with columns; bracketed cornices, inc. at bay and porch; decorative chimneys; replacement siding; wood windows; cresting; paneled bays	C

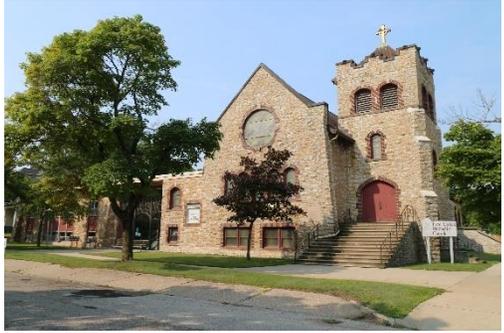
#	Address	Date	Comments	Status	Photo
77	302 S 6 <sup>th</sup> St	1907	Massing and form intact, addition c. 1964; dressed fieldstone walls; brick arches with keystones and quoins at arched windows and entries; rose/oculus window with brick surround; crenellations at tower; exposed buttresses	C

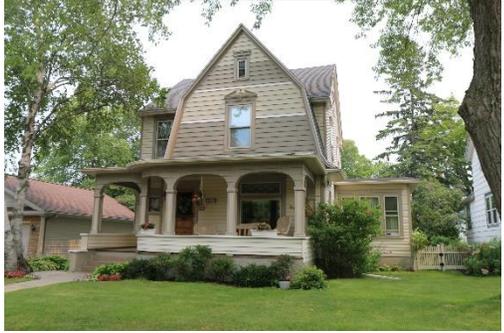
78	309 S 6 <sup>th</sup> St	c. 1885	Form and massing intact; shingle and replacement siding; decorative window hoods; historic windows; full-width porch with paneled posts	C

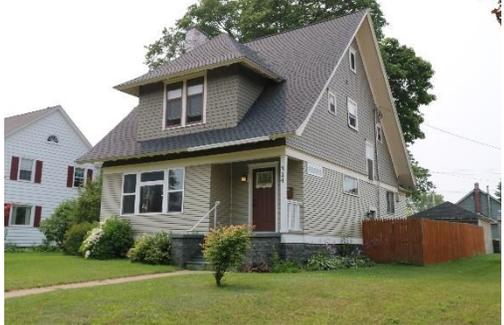
79	314 S 6 <sup>th</sup> St	c. 1915	Form and massing generally intact; clapboard and shingle siding; combination of historic and replacement windows; inset porch; rafter tails at façade eave; rusticated foundation	C

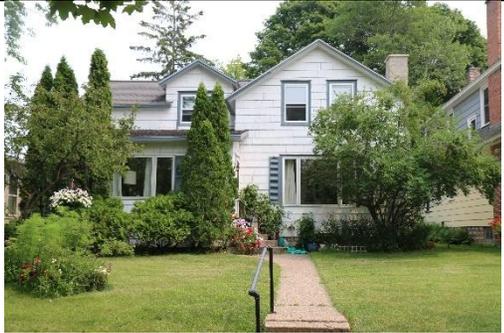
80	315 S 6 <sup>th</sup> St	c. 1885	Form and massing generally intact; front porch enclosure; shingle cladding; combination of historic and replacement windows; rusticated foundation; chimney rebuilt	C

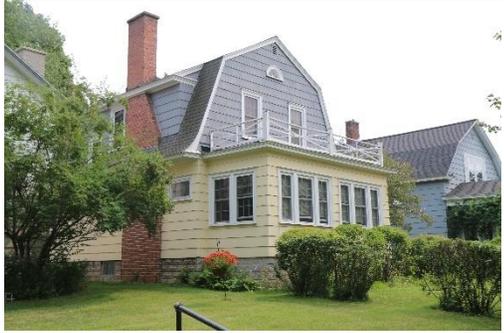
#	Address	Date	Comments	Status	Photo
81	317 S 6 <sup>th</sup> St	c. 1910	Form and massing generally intact; front addition/enclosure; rusticated block foundation; shingle and replacement siding cladding; replacement windows	C

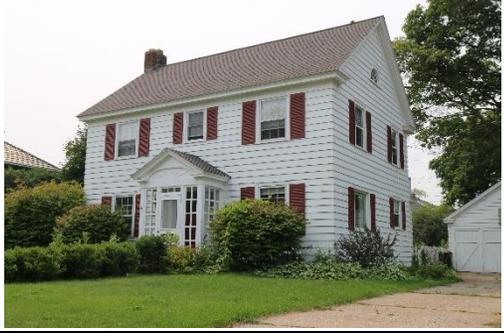
82	320 S 6 <sup>th</sup> St	c. 1935	Form and massing intact; bevel siding; combination of historic and replacement windows; entry portico enclosed; single-leaf entry with fanlights; dentiled cornice	C

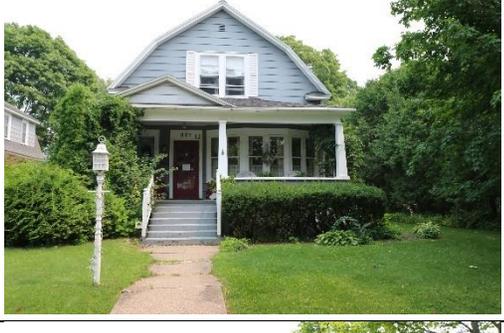
83	321 S 6 <sup>th</sup> St	c. 1910	Form and massing intact; Masonite cladding; historic windows; multi-part bay at first floor; full-width porch with battered posts	C

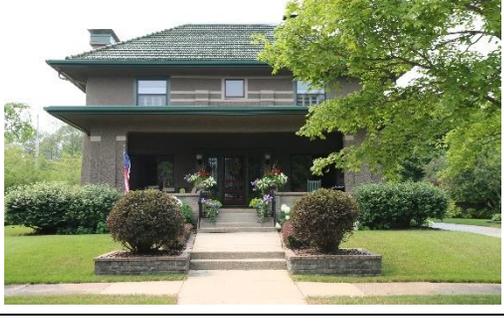
84	326 S 6 <sup>th</sup> St	c. 1911	Form and massing intact; tile roof; stucco cladding; historic windows; full-width porch; decorative coursework; single-leaf entry with sidelights; wide boxed eaves; battered chimney	C

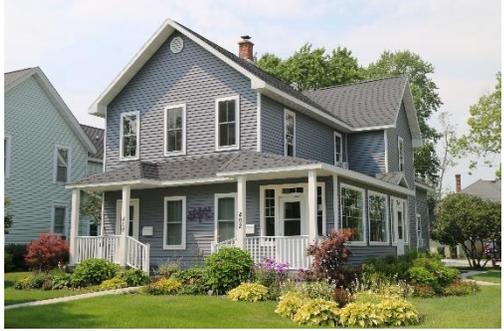
#	Address	Date	Comments	Status	Photo
85	402-404 S 6 <sup>th</sup> St	c. 1895	Form and massing generally intact, but altered through porch changes/enclosures; replacement elements at porch; replacement siding; replacement windows; entry alteration	NC

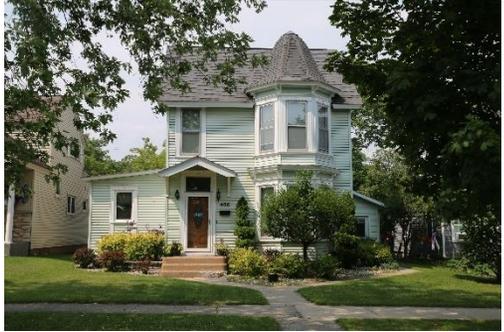
86	406 S 6 <sup>th</sup> St	c. 1880	Form and massing generally intact, historic side additions; replacement siding; tower with decorative cornice and window hoods; combination historic and replacement windows; replacement entry with transom	C

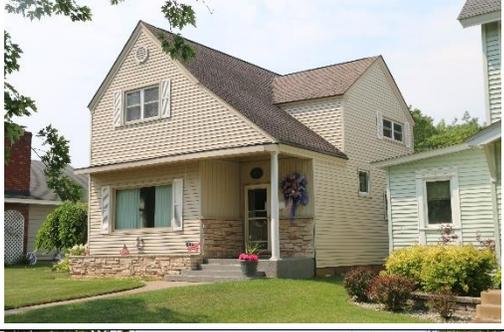
87	408 S 6 <sup>th</sup> St	c. 1890	Form and massing significantly altered; replacement siding; replacement windows and altered openings; stone veneer at inset porch and foundation	NC

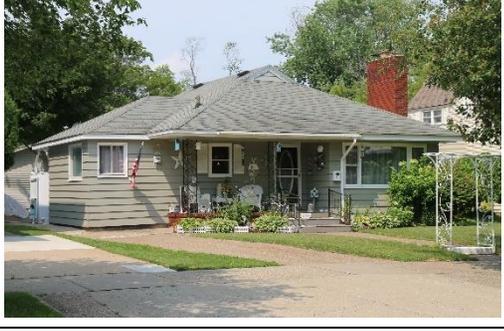
88	414 S 6 <sup>th</sup> St	c. 1950	Outside period of significance	NC

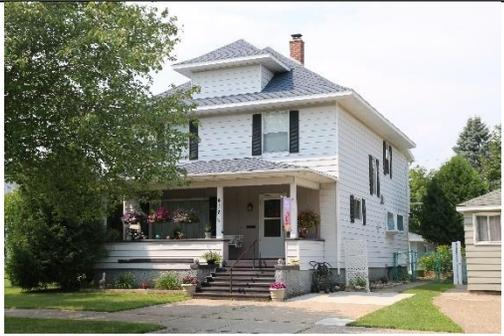
#	Address	Date	Comments	Status	Photo
89	416 S 6 <sup>th</sup> St	c. 1915	Form and massing generally intact; replacement siding; board-and-batten at entry; combination of historic and replacement windows; altered first-story opening; windows removed from dormer; full-width porch with posts; parged foundation	NC

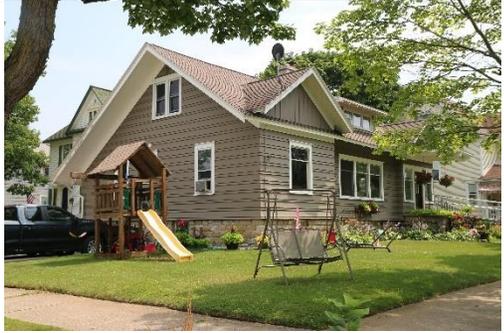
90	505 S 6 <sup>th</sup> St	c. 1925	Form and massing generally intact, porch enclosure; novelty wood lap siding; board and batten in gable; exposed rafter tails at broad eave; wood windows; rusticated foundation	C

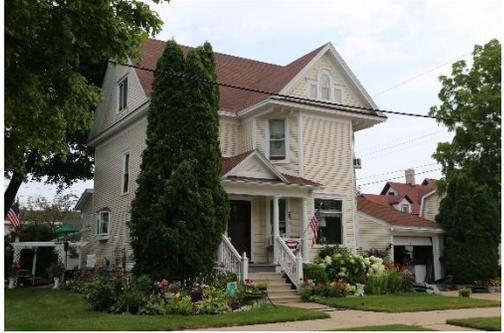
91	511 S 6 <sup>th</sup> St	c. 1900	Form and massing generally intact, historic addition; clapboard siding; historic windows; partial-width porch with columns and balustrade; multi-light windows with decorative hood in gable	C

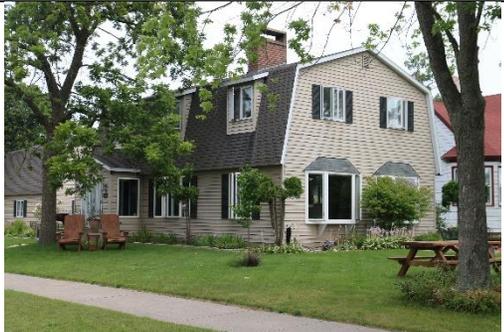
92	513 S 6 <sup>th</sup> St	c. 1980	Outside period of significance	NC

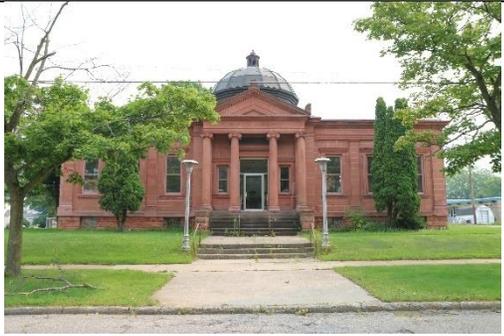
#	Address	Date	Comments	Status	Photo
93	205 S 7 <sup>th</sup> St	1902	Exposed sandstone walls; full-height portico with entablature, pediment, and Ionic columns; decorative window hoods; pilasters at bays; wood windows  Individually listed in the NR; part of Escanaba Central HD	C

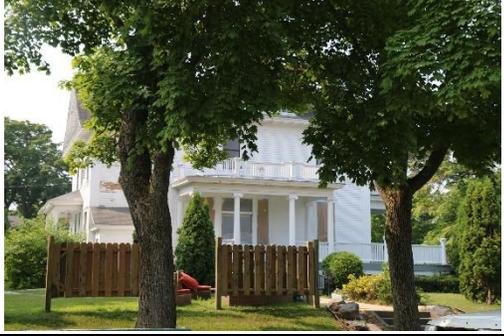
94	301 S 7 <sup>th</sup> St	c. 1900	Form and massing intact; clapboard siding; wood windows throughout; full-width and side porch with columns; wide eave with bracket and beading; full-height fluted pilasters at corners	C

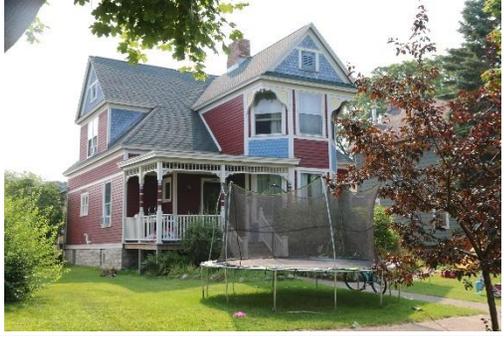
95	309 S 7 <sup>th</sup> St	c. 1890	Form and massing intact; clapboard and scalloped siding; partial-width porch with decorative scrollwork and turned posts; historic windows; chamfered bay	C

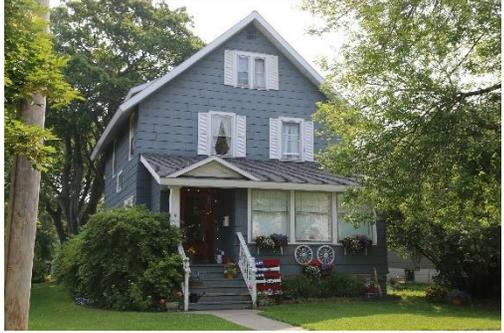
#	Address	Date	Comments	Status	Photo
97	317 S 7 <sup>th</sup> St	c. 1910	Form and massing generally intact; partially enclosed full-width porch; asbestos siding; historic windows; historic single-leaf entry; rusticated block foundation	C

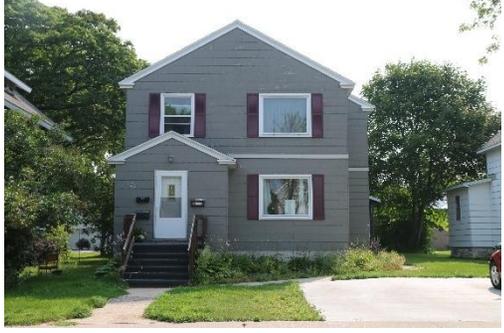
98	321 S 7 <sup>th</sup> St	c. 1900	Form and massing generally intact, but enclosed front porch; replacement windows and altered openings; asbestos siding	NC

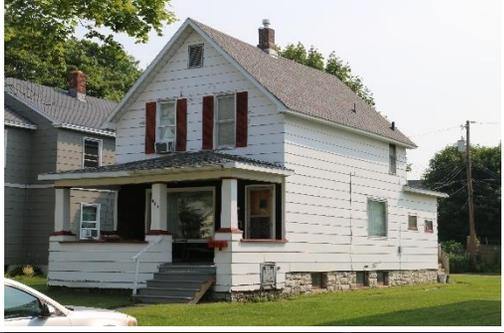
99	325 S 7 <sup>th</sup> St	c. 1900	Form and massing generally intact; Masonite siding; historic windows, except first-floor façade window altered; full-width porch with battered posts	C

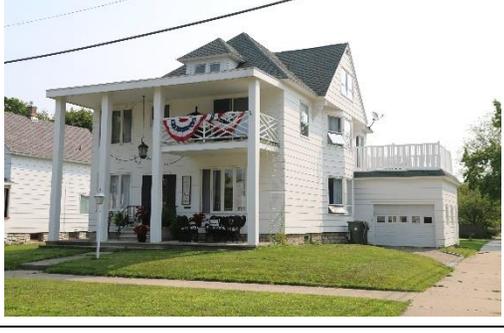
100	327 S 7 <sup>th</sup> St	c. 1895	Historic additions; replacement siding; replacement windows; porch configuration and elements altered; window configuration altered.	NC

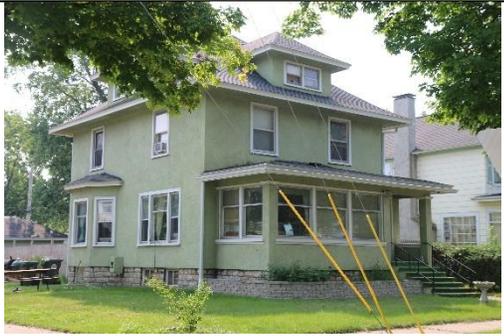
#	Address	Date	Comments	Status	Photo
101	403 S 7 <sup>th</sup> St	c. 1905	Form and massing intact; stucco cladding; historic and replacement windows; full-width porch partially enclosed	C

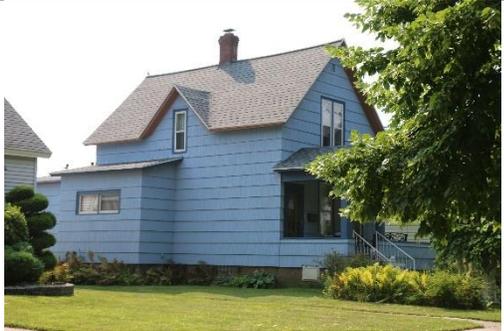
#	Address	Date	Comments	Status	Photo
105	417 S 7 <sup>th</sup> St	c. 1900	Form and massing generally intact; replacement siding; historic windows; replaced entry; full-width porch	C

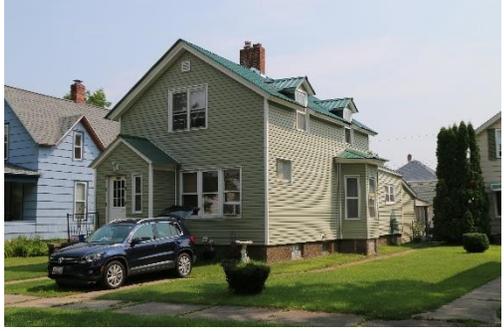
106	421 S 7 <sup>th</sup> St	c. 1895	Form and massing generally intact, but enclosed front porch; combination of historic and replacement windows; replacement siding; replacement roof material	NC

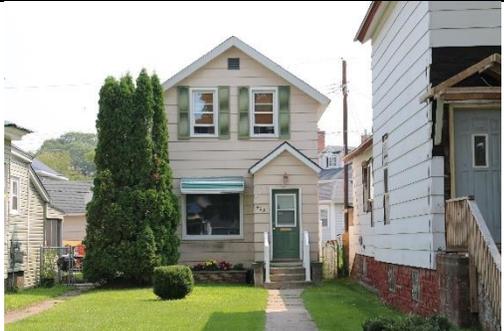
107	423 S 7 <sup>th</sup> St	c. 1895	Form and massing generally intact, but enclosed front porch; Masonite siding; replacement windows; altered first floor opening	NC

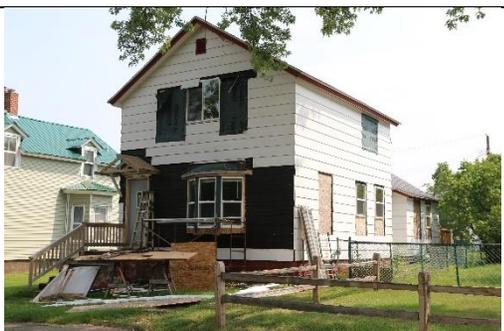
108	425 S 7 <sup>th</sup> St	c. 1895	Form and massing generally intact; replacement siding; replacement windows and altered openings; replacement entry	NC

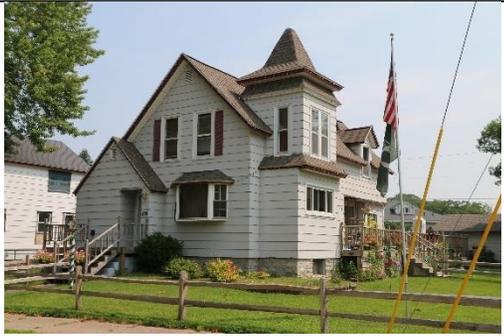
#	Address	Date	Comments	Status	Photo
109	429 S 7 <sup>th</sup> St	c. 1890	Form and massing generally intact, but porch enclosed; Masonite siding; combination of historic and replacement windows; some window configurations altered; vinyl surrounds	NC

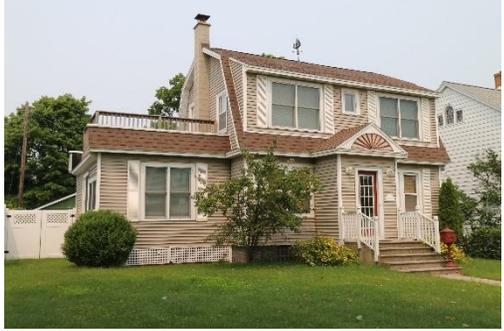
#	Address	Date	Comments	Status	Photo
113	212 Lake Shore Dr	c. 1915	Form and massing generally intact, historic side addition; front porch enclosed; combination of historic and replacement windows; some altered openings; replacement siding	NC

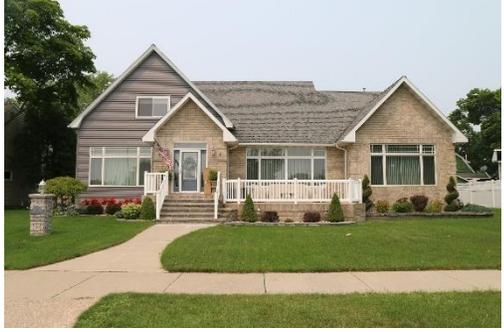
114	218 Lake Shore Dr	c. 2010	New construction	NC

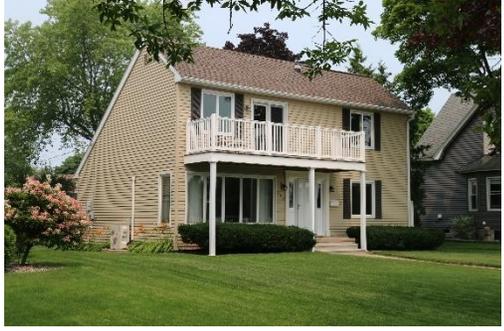
115	222 Lake Shore Dr	c. 1975	Outside period of significance	NC

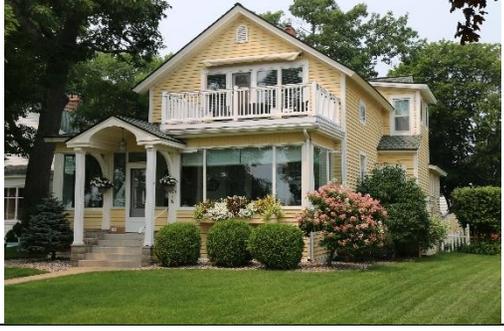
116	226 Lake Shore Dr	c. 1885	Form and massing altered by wraparound porch enclosed, battered posts remain evident; clapboard siding; combination of historic and replacement windows; pedimented entry hood	NC

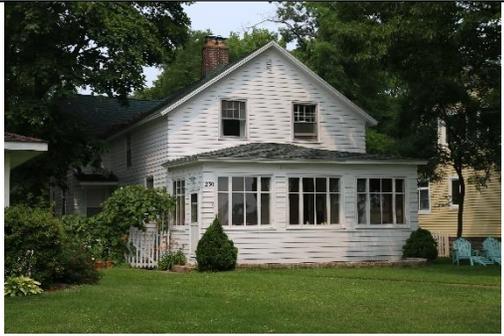
#	Address	Date	Comments	Status	Photo
117	230 Lake Shore Dr	c. 1910	Form and massing generally intact, but front porch enclosed; lap siding; combination of historic and replacement windows	C

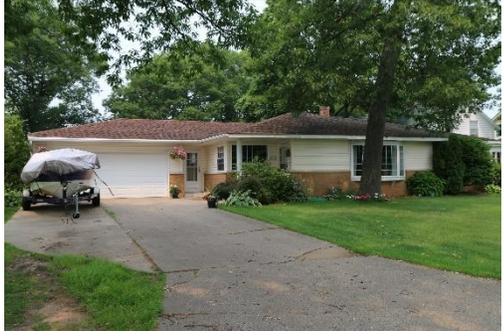
118	236 Lake Shore Dr	c. 1960	Outside period of significance	NC

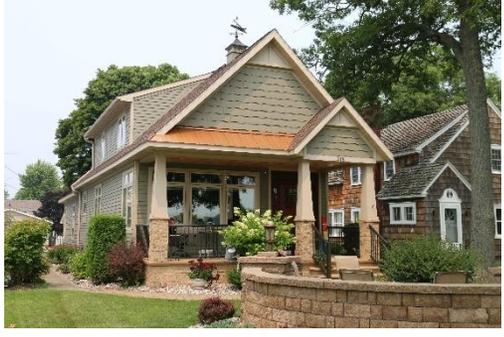
119	248 Lake Shore Dr	c. 2015	New construction	NC

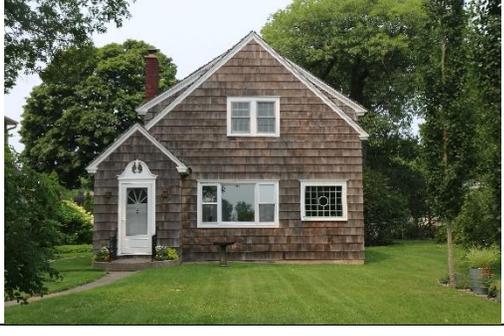
120	248A Lake Shore Dr	c. 1915	Form and massing generally intact; shingle cladding; wood windows	C

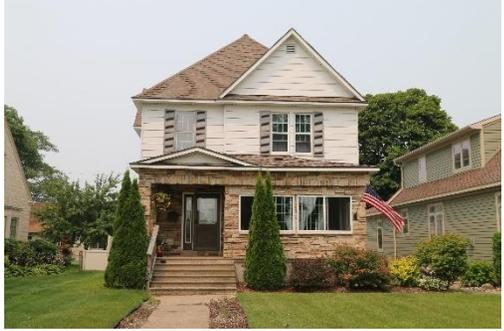
#	Address	Date	Comments	Status	Photo
121	250 Lake Shore Dr	c. 1900	Form and massing generally intact; full-width porch partially enclosed and stone veneer; replacement windows; some altered window openings	NC

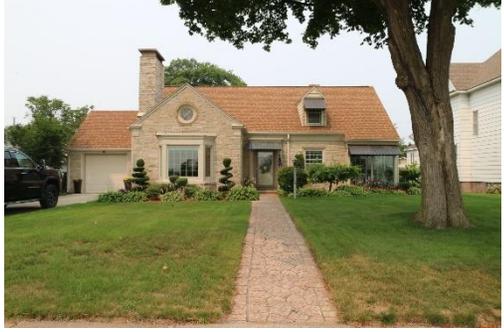
122	254 Lake Shore Dr	c. 1940	Form and massing intact; dressed stone exterior; shingles at dormer; historic windows; dentiled cornice; cornice returns	C

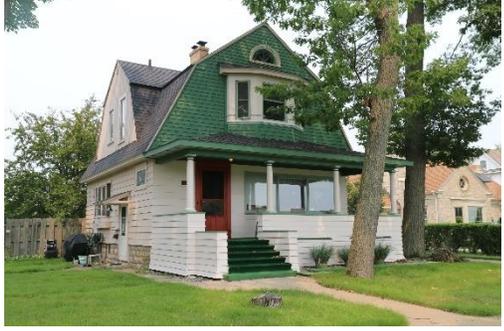
123	260 Lake Shore Dr	c. 1910	Form and massing generally intact; combination claddings, shingle, vertical board, and bevel; full-width porch with column on kneewall; wood windows	C

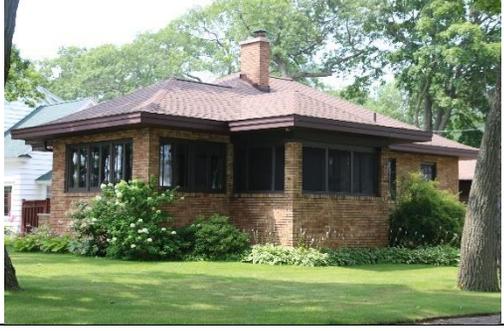
124	302 Lake Shore Dr	c. 1925	Form and massing intact; brick veneer; historic windows	C

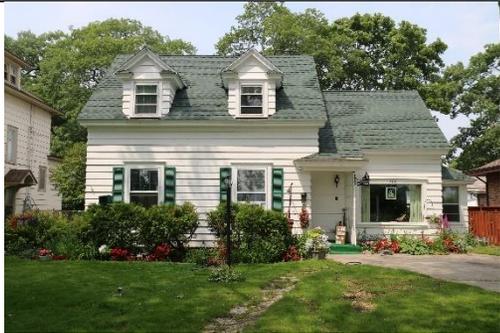
#	Address	Date	Comments	Status	Photo
125	306 Lake Shore Dr	c. 1905	Form and massing generally intact; lap siding; historic windows; pedimented dormers; inset porch	C

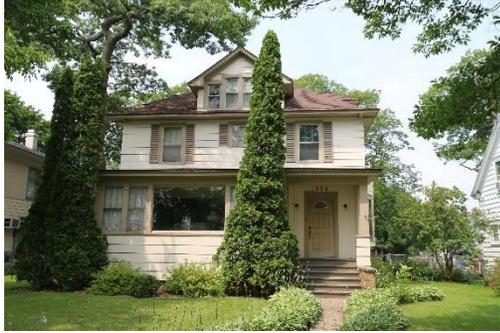
126	310 Lake Shore Dr	c. 1910	Form and massing generally intact; full-width porch partially enclosed; replacement siding, vertical board at entry; wood windows	C

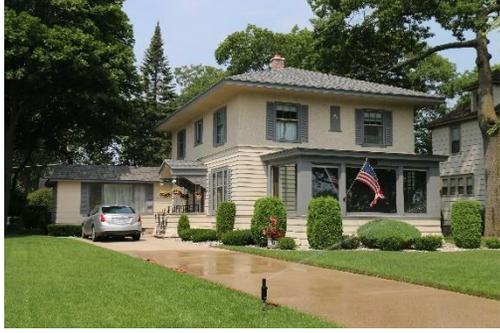
127	314 Lake Shore Dr	c. 1920	Form and massing generally intact; bevel siding at first floor and stucco cladding at second; flared eave; wood windows; pedimented entry hood with decorative scrollwork	C

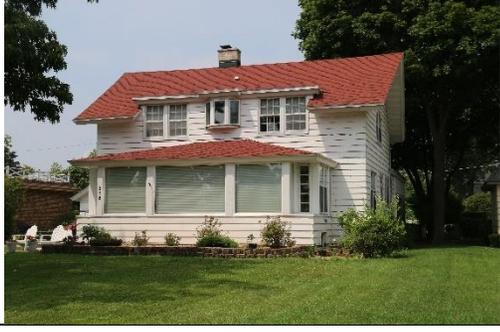
128	318 Lake Shore Dr	c. 1920	Form and massing generally intact; replacement siding; combination of historic and replacement windows; second-story bay replaced	C

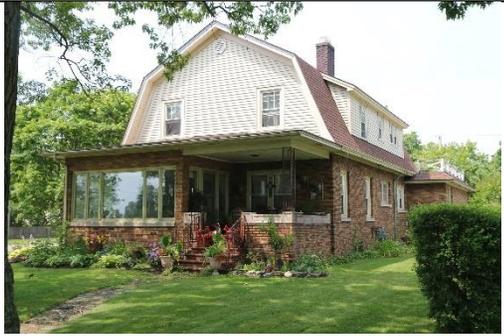
#	Address	Date	Comments	Status	Photo
129	322 Lake Shore Dr	c. 1930	Form and massing generally intact; second-story replacement siding and first floor brick-veneer; combination of historic and replacement windows	C

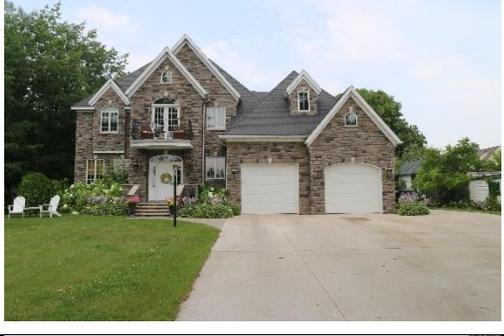
131	408 Lake Shore Dr	c. 2010	New construction	NC

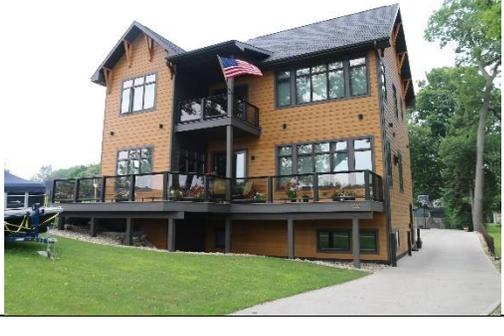
132	420 Lake Shore Dr	c. 2015	New construction	NC

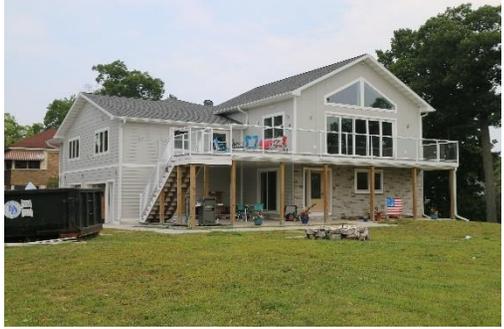
#	Address	Date	Comments	Status	Photo
133	430 Lake Shore Dr	2022	New construction	NC

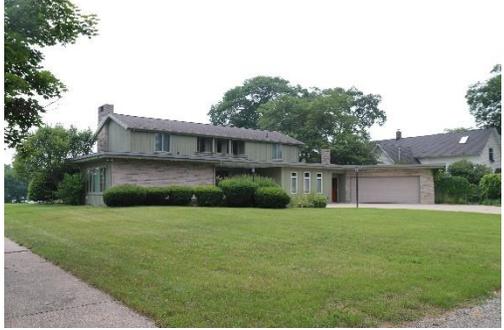
134	500 Lake Shore Dr	c. 1960	Outside period of significance	NC

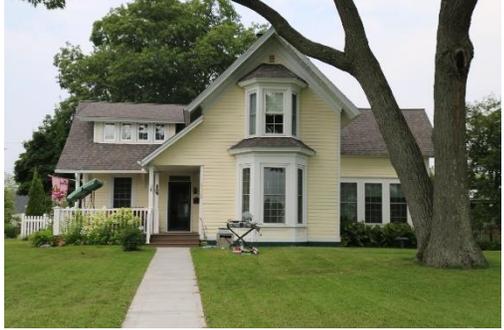
135	512 Lake Shore Dr	c. 1870	Form and massing generally intact; lap siding; combination of historic and replacement windows; partial-width porch; single-leaf entry with transom	C

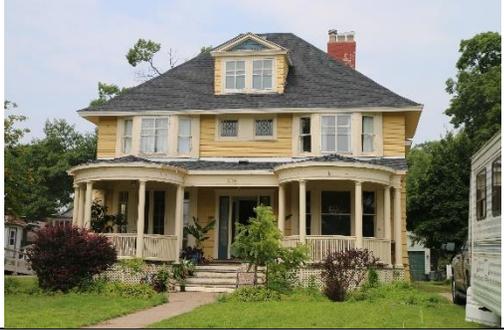
136	516 Lake Shore Dr	c. 1910	Form and massing generally intact, historic rear addition; bevel and clapboard siding; wood windows throughout; flared eave; full-width porch with columns; three-party entry with sidelights; lacework in upper-story windows	C

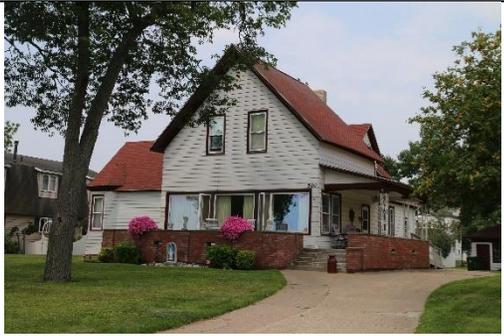
#	Address	Date	Comments	Status	Photo
137	520 Lake Shore Dr	c. 1890	Historic additions; replacement siding; replacement windows; window configuration altered	NC

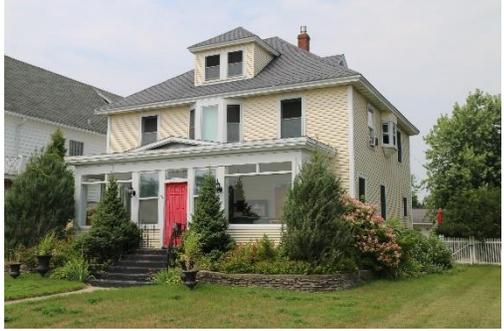
#	Address	Date	Comments	Status	Photo
141	618 Lake Shore Dr	c. 1900	Form and massing generally intact, but full-width front porch enclosed; replacement siding; combination of historic and replacement windows; added bay at second floor	NC

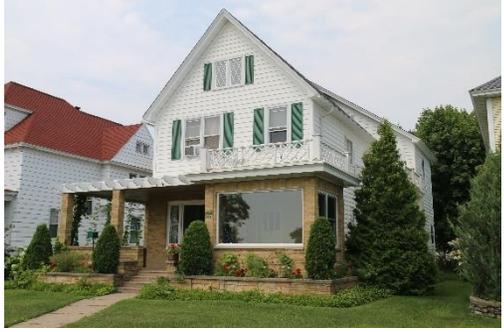
142	622 Lake Shore Dr	c. 1900	Form and massing generally intact; wraparound porch partially enclosed and clad in brick veneer; replacement siding; combination of historic and replacement windows	NC

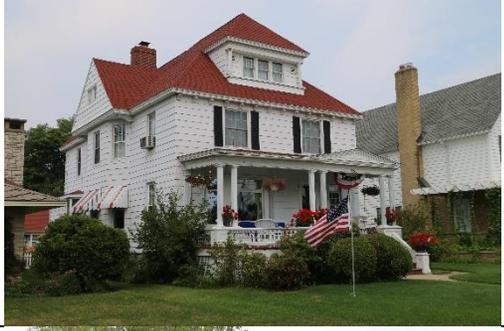
143	624 Lake Shore Dr	c. 1890	Form and massing intact; replacement siding; historic windows; full-width porch with paired columns, paneled piers, and pilasters; brackets at eave; dentiled cornice and columns at dormer;	C

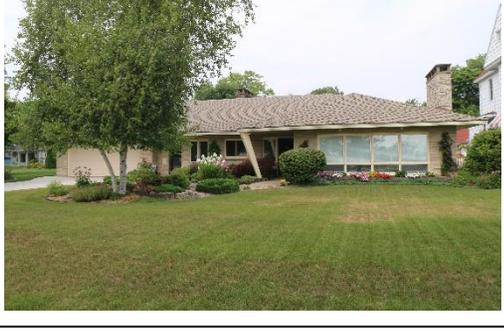
144	630 Lake Shore Dr	c. 1955	Outside period of significance	NC

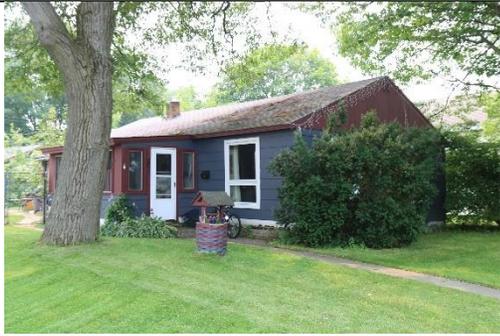
#	Address	Date	Comments	Status	Photo
145	201 Ogden	c. 1900	Form and massing generally intact; replacement siding; replacement entry; replacement windows	NC

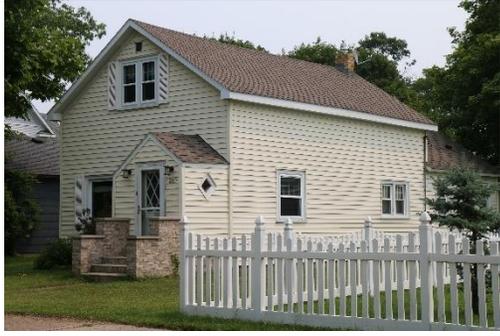
146	205 Ogden	c. 1910	Form and massing generally intact; replacement siding; replacement windows; front porch enclosed; window opening alterations	NC

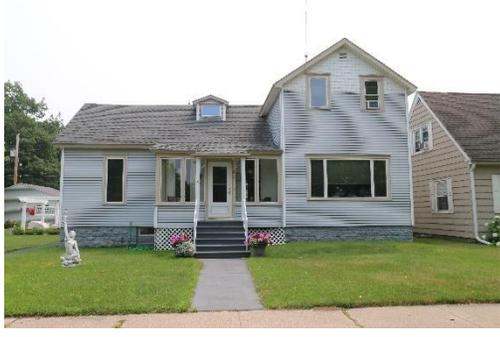
147	215 Ogden	c. 1900	Form and massing generally intact, but front porch enclosed; replacement windows; window openings altered; replacement siding	NC

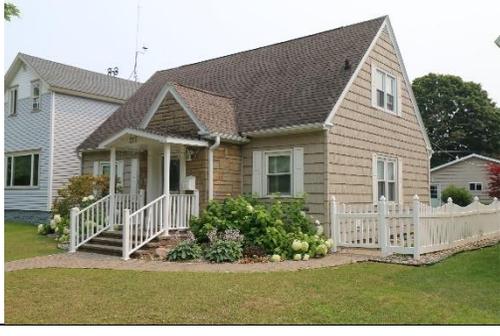
148	217 Ogden	c. 1945	Form and massing generally intact; front porch enclosed and clad in stone veneer; replacement shingle siding; replacement windows	NC

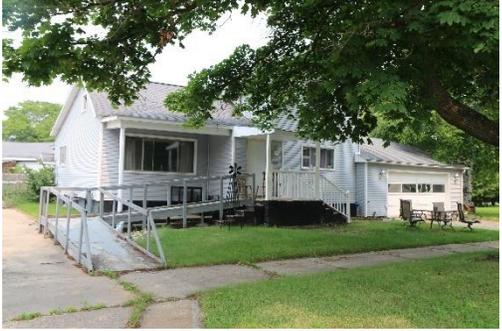
#	Address	Date	Comments	Status	Photo
149	220 Ogden	c. 1895	Form and massing altered through additions, front porch altered; window openings altered; replacement siding; replacement windows	NC

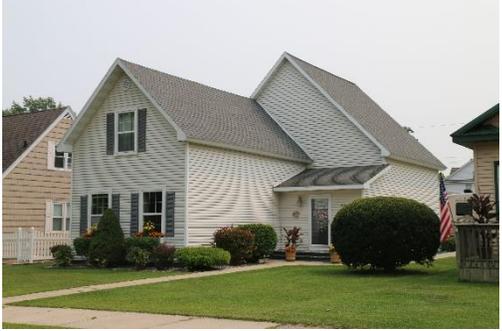
150	225 Ogden	c. 2005	New construction	NC

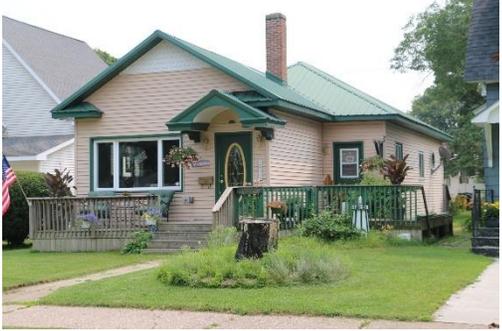
151	227 Ogden	c. 1900	Form and massing altered; porch enclosed; replacement windows; window openings altered; replacement entries; replacement roof material; replacement siding	NC

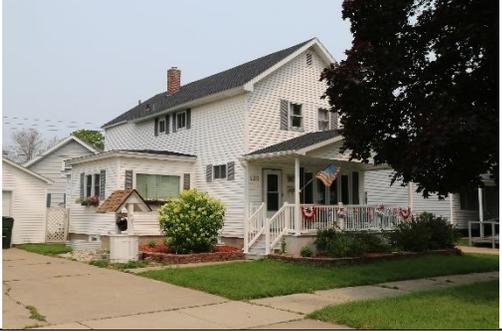
152	230 Ogden	c. 1900	Form and massing generally intact, historic addition; replacement siding; replacement windows; some window openings altered; replacement entry; modern porch elements	NC

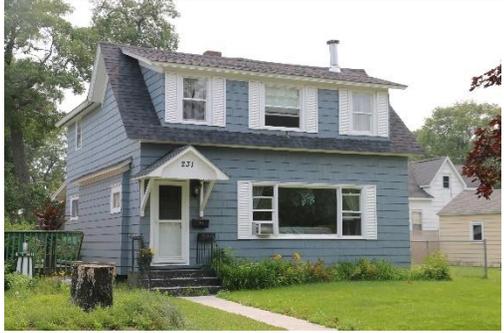
#	Address	Date	Comments	Status	Photo
153	231 Ogden	c. 1915	Form and massing generally intact; shingle cladding; historic windows	C

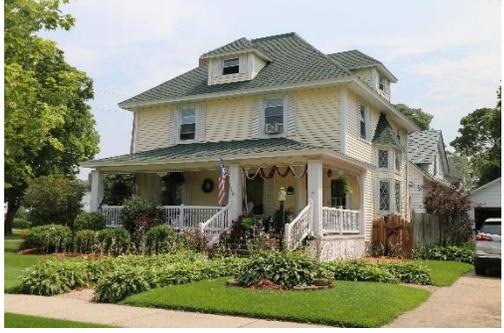
154	303 Ogden	c. 1910	Form and massing generally intact; replacement siding; replacement windows; full-width porch but replaced/wrapped columns, replacement balustrade	NC

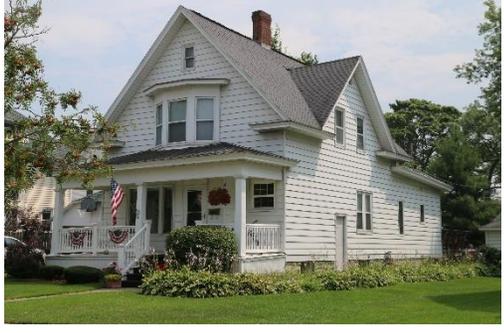
155	307 Ogden	c. 1890	Form and massing intact; replacement siding; replacement windows; full-width porch	C

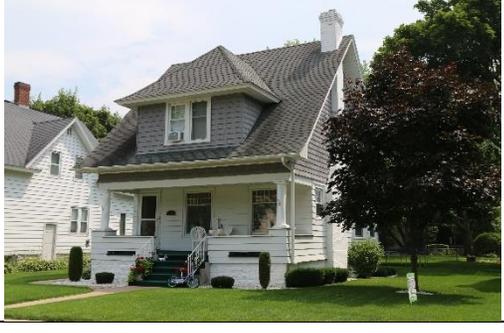
156	311 Ogden	c. 1910	Form and massing intact; replacement siding on first story and shingle on second; historic windows; full-width porch with columns on end wall; corbeled chimney; flared eaves	C

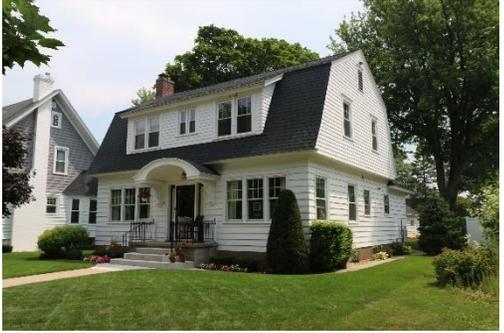
#	Address	Date	Comments	Status	Photo
157	315 Ogden	c. 1910	Form and massing intact; lap siding on first story and shingle on second; historic windows; single-leaf entry with sidelights; entry wood with brackets; paired windows at dormer	C

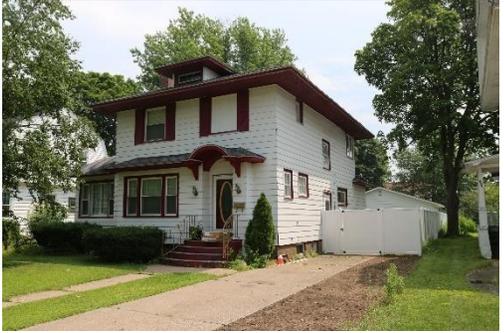
158	317 Ogden	c. 1910	Form and massing generally intact, historic addition; porch enclosed; replacement entry; combination of historic and replacement windows; replacement siding; boarded over window opening; dormer window altered	NC

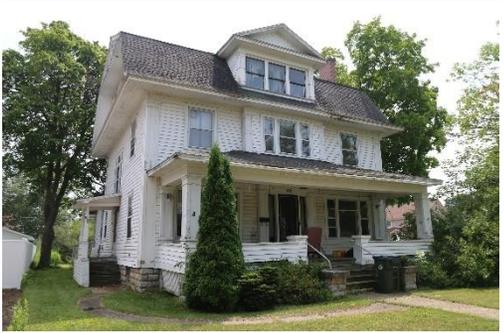
159	323 Ogden	c. 1895	Form and massing generally intact, historic additions; replacement siding; combination of replacement and historic windows; full-width porch with paneled columns; paneled pilasters at corners, entry, and upper story windows; single-leaf entry with sidelights	C

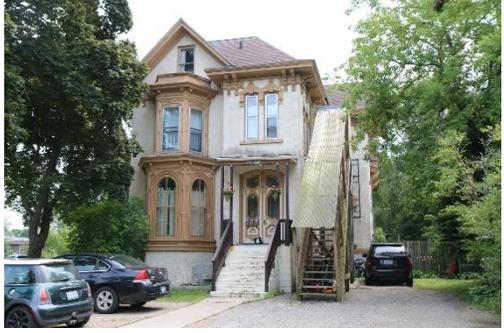
163	408 Ogden	c. 1895	Form and massing altered through porch configuration; replacement siding; replacement windows; altered window configuration; replacement doors	NC
