# SUMMARY REPORT

# CITY OF ESCANABA

# OGDEN TRIANGLE HISTORIC RESOURCE INVENTORY

Prepared for the City of Escanaba  
April 2023

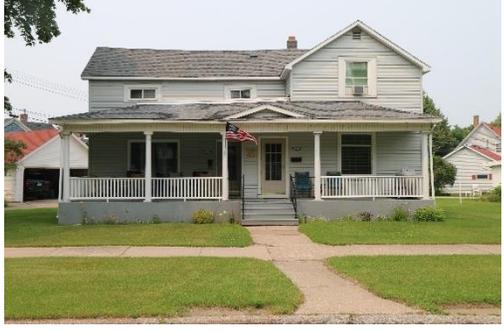
164	411 Ogden	c. 1900	Form and massing intact; asbestos shingles; historic windows; scalloped entry hood with brackets	C

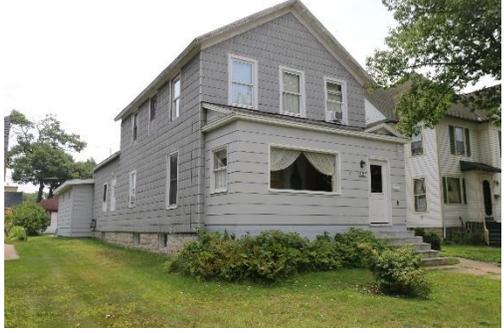
171	523 Ogden	c. 1895	Form and massing intact; enclosed porch; replacement siding; shingle in gable end; historic windows; decorative window hoods in gables; rusticated foundation	C

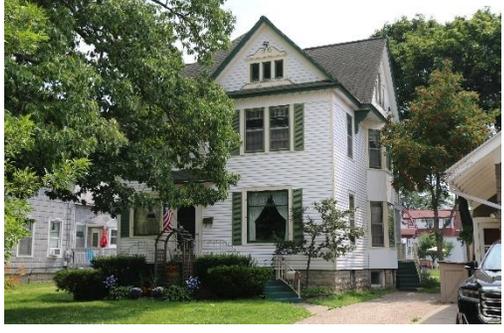
172	601 Ogden	c. 1900	Form and massing intact, historic addition; clapboard siding; wood windows throughout; flared eaves with bracketed cornice; double-leaf entry with transom; dentiled porch; splayed window hoods at first story	C

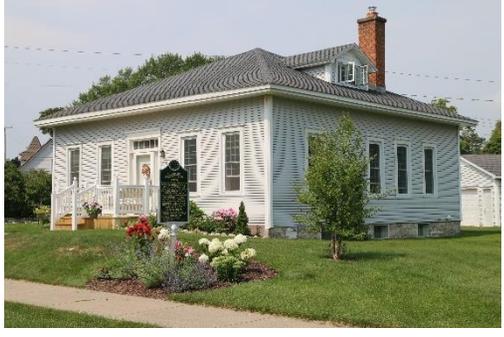
175	611 Ogden	c. 1895	Form and massing generally intact, historic addition; replacement siding; wood windows; inset porch; rusticated foundation	C

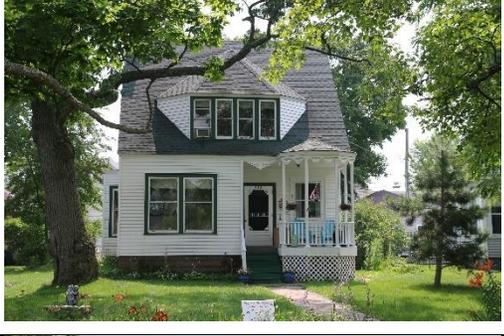
176	615 Ogden	c. 1900	Form and massing generally intact; replacement siding; replacement windows; entry altered with new single-leaf door and sidelight; porch reconstructed	NC

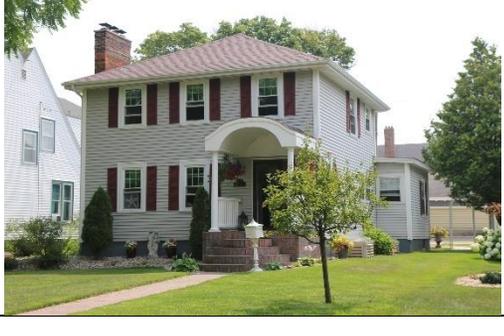
#	Address	Date	Comments	Status	Photo
177	619 Ogden	c. 1940	Form and massing generally intact; replacement siding; historic windows	C

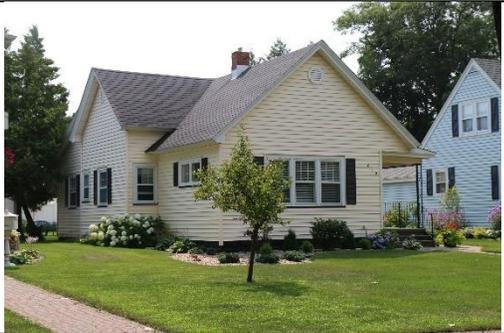
178	625 Ogden	c. 1940	Form and massing intact; replacement siding; historic windows	C

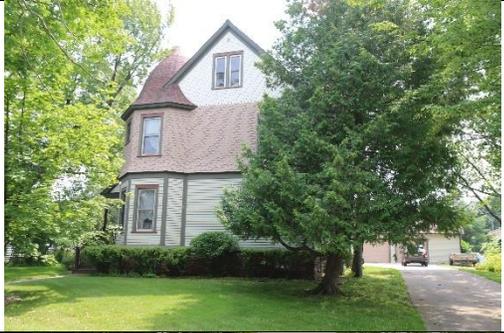
180	635 Ogden	c. 1890	Form and massing generally intact; clapboard siding; novelty siding in gable; ¾-width porch with turned posts, spindlework, sunburst in gable; vergeboard; wood windows; chamfered bays	C
