# City of Escanaba Wastewater System Improvements

Michigan Clean Water State Revolving Fund Project Plan (2023)  
Volume 2 – Appendix (FINAL)

22-0290

April 26, 2023

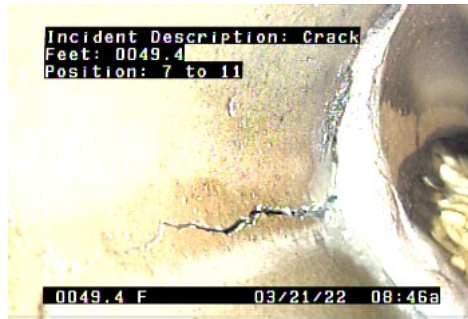
C - Crack @ 49.4 ft.

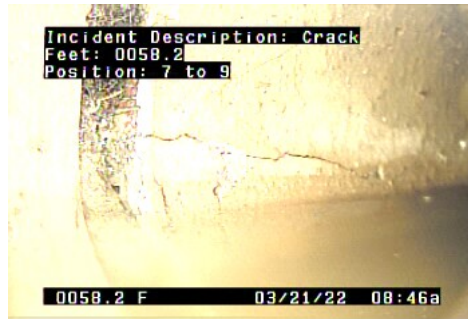
C - Crack @ 58.2 ft.

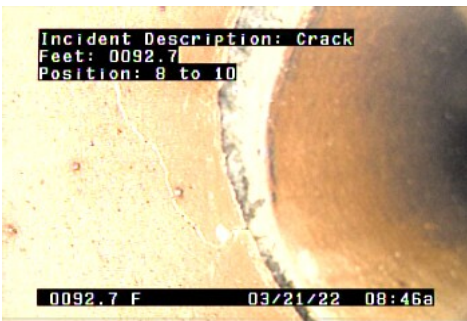
C - Crack @ 92.7 ft.

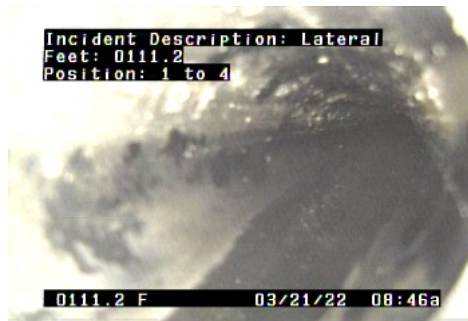
C - Crack @ 111.2 ft.

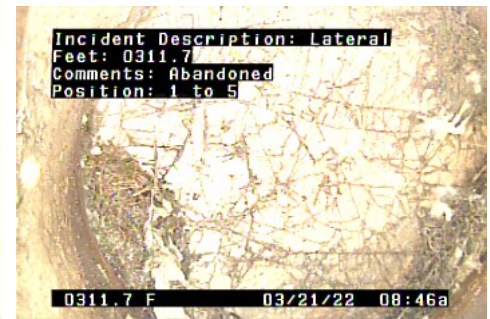
L - Lateral @ 311.7 ft. Abandoned

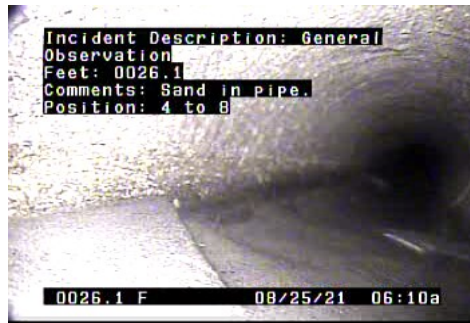
GO - General Observation @ 26.1 ft.  
Sand in pipe.

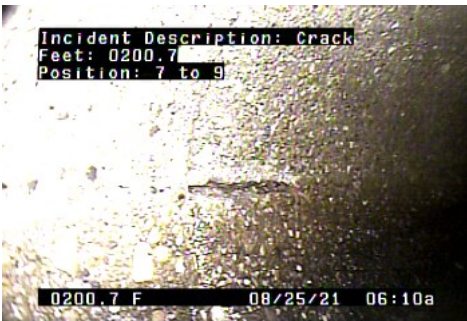
C - Crack @ 200.7 ft.

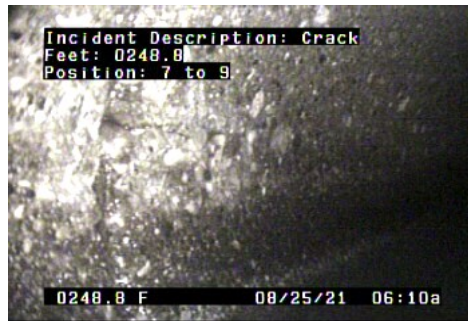
C - Crack @ 248.8 ft.

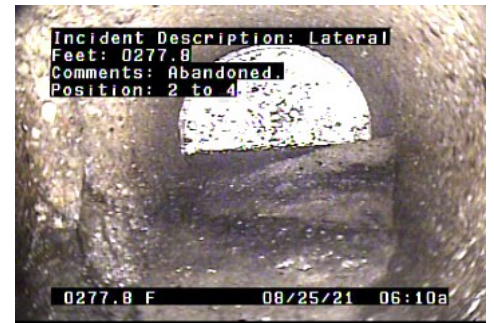
L - Lateral @ 277.8 ft. Abandoned.

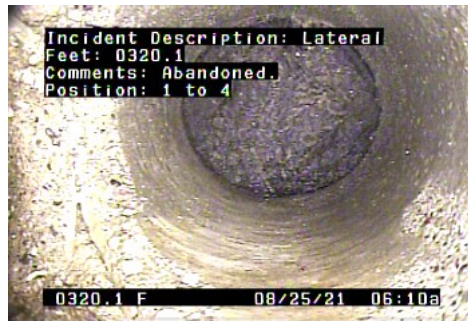
L - Lateral @ 320.1 ft. Abandoned.

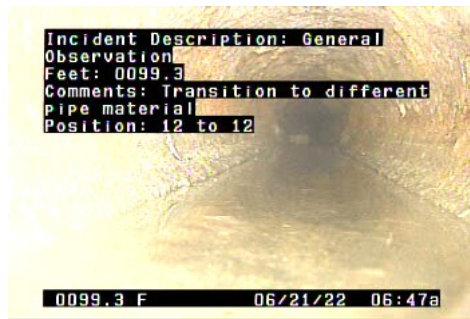
GO - General Observation @ 99.3 ft. Transition to different pipe material

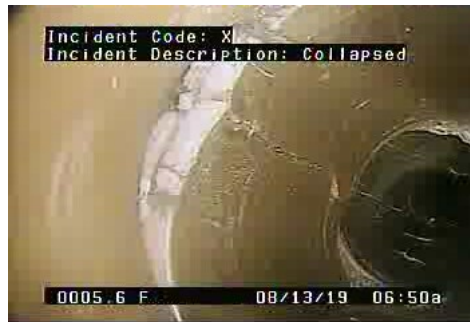
| <b>Comments</b><br>Manhole ... Sink hole | | | <b>Pre-Cleaning</b><br>No Pre-Cleaning | <b>TV Length</b><br>6.9 |

X - Collapsed @ 6.9 ft. Sewer collapsed

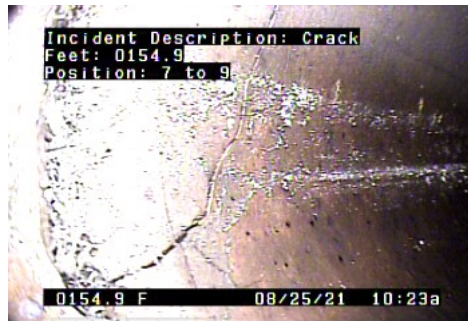
C - Crack @ 154.9 ft.

| Ftg. | Code | Description | Position | Severity | Comment |
|---|---|---|---|---|--|
| 154.9 | C | Crack | 7 to 9 | 2 | |

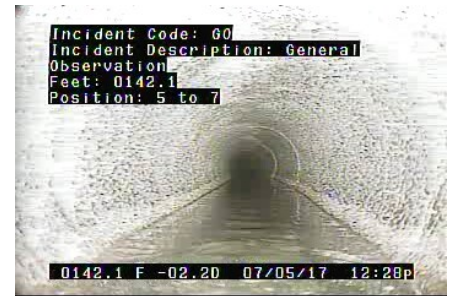
GO - General Observation @ 142.1 ft.  
Dip in pipe at about 140 feet, camera under water can't see.

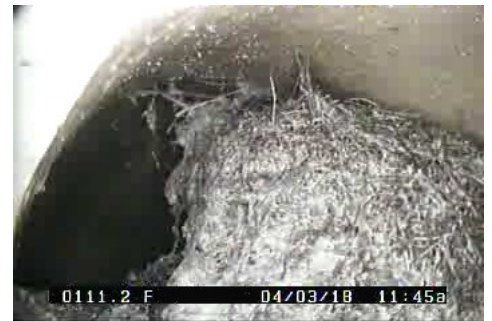
SC - Service Connection @ 111.2 ft.  
Roots in lateral

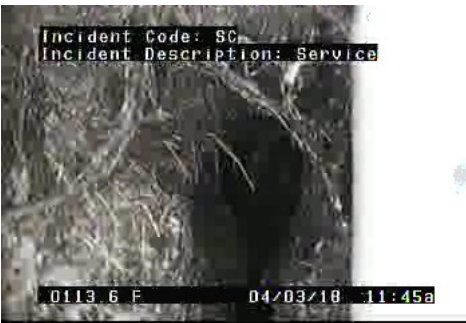
SC - Service Connection @ 113.6 ft.  
Roots in lateral

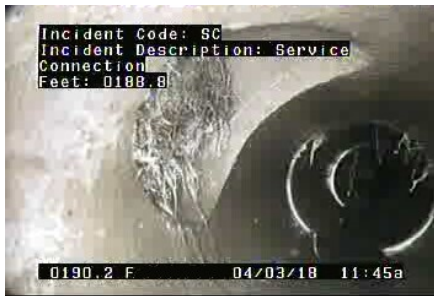
SC - Service Connection @ 188.8 ft.  
Roots in Lateral. Believe this is Mr. Lampi service connection.

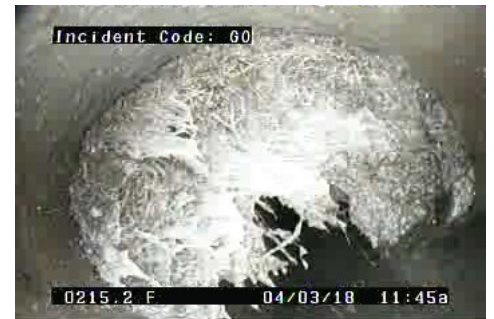
GO - General Observation @ 214.9 ft.  
Large amount of roots in the pipe.

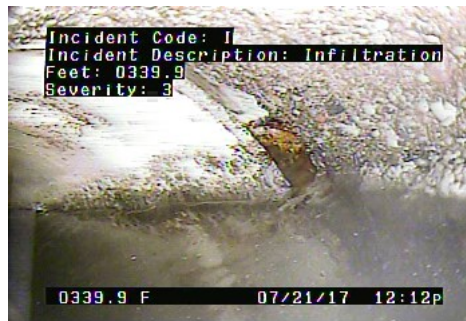
| | Ftg. | Code | Description | Position | Severity | Comment |
|---|---|---|---|---|---|---|
| | 339.9 | I | Infiltration | 2 to 4 | 3 | |

I - Infiltration @ 339.9 ft.

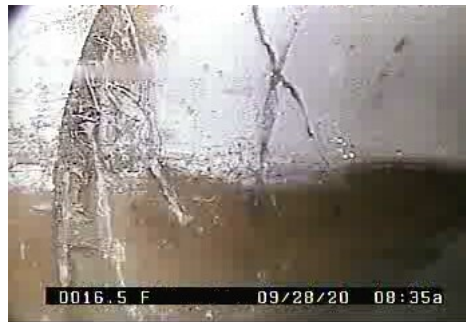
| | Ftg. | Code | Description | Position | Severity | Comment |
|---|---|---|---|---|---|---|
| | 16.5 | C | Crack | 8 to 11 | 2 | |

C - Crack @ 16.5 ft.

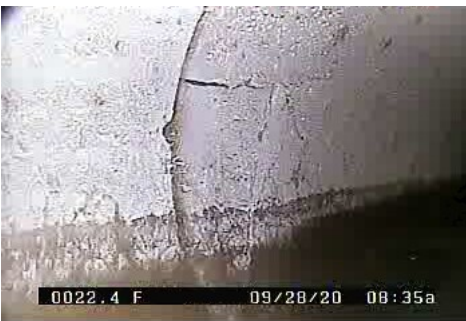
| | Ftg. | Code | Description | Position | Severity | Comment |
|---|---|---|---|---|---|---|
| | 22.4 | C | Crack | 8 to 11 | 2 | |

C - Crack @ 22.4 ft.

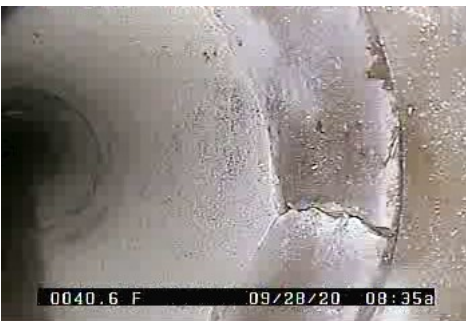
| | Ftg. | Code | Description | Position | Severity | Comment |
|---|---|---|---|---|---|---|
| | 38.5 | C | Crack | 10 to 2 | 2 | |

C - Crack @ 38.5 ft.

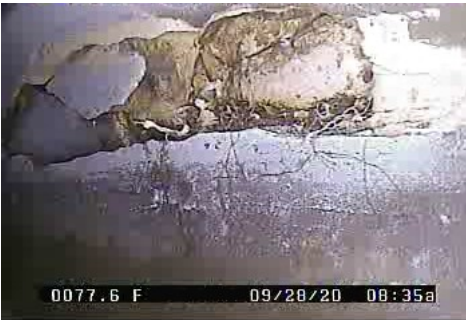
| | Ftg. | Code | Description | Position | Severity | Comment |
|---|---|---|---|---|---|---|
| | 77.6 | C | Crack | 1 to 5 | 10 | Real Bad! |

C - Crack @ 77.6 ft. Real Bad!

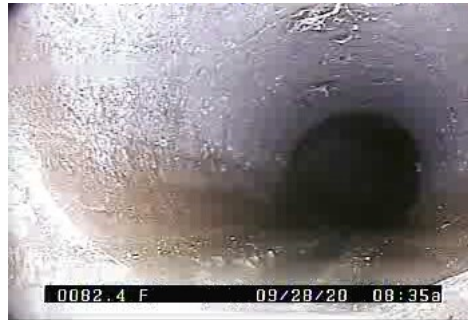
SC - Service Connection @ 82.4 ft.

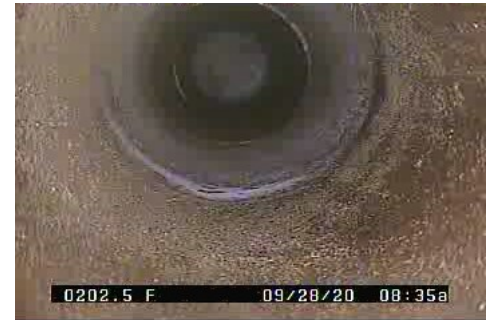
SC - Service Connection @ 202.5 ft. Not sure what this is?

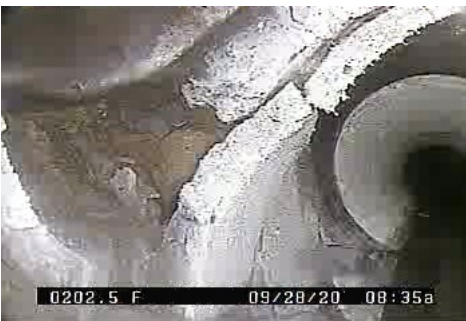
| | Ftg. | Code | Description | Position | Severity | Comment |
|---|---|---|---|---|---|---|
| | 202.5 | C | Crack | 12 to 12 | 10 | |

C - Crack @ 202.5 ft.

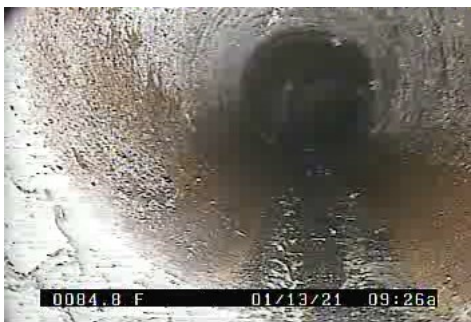
SC - Service Connection @ 84.8 ft.

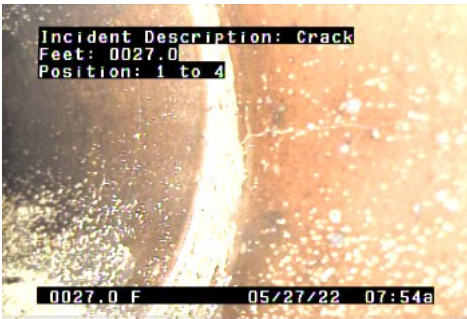
| | Ftg. | Code | Description | Position | Severity | Comment |
|--|---|---|---|---|---|--|
| | 27.0 | C | Crack | 1 to 4 | 2 | |

C - Crack @ 27.0 ft.

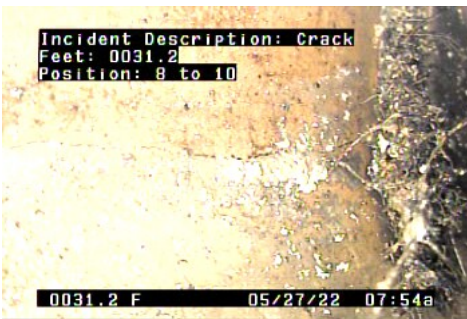
| | Ftg. | Code | Description | Position | Severity | Comment |
|--|---|---|---|---|---|--|
| | 31.2 | C | Crack | 8 to 10 | 2 | |

C - Crack @ 31.2 ft.

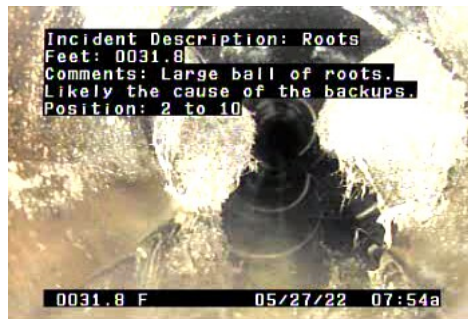
R - Roots @ 31.8 ft. Large ball of roots. Likely the cause of the backups.

| Ftg. | Code | Description | Position | Severity | Comment |
|---|---|---|---|---|---|
| 31.8 | R | Roots | 2 to 10 | 3 | Large ball of roots. Likely the cause of the backups. |

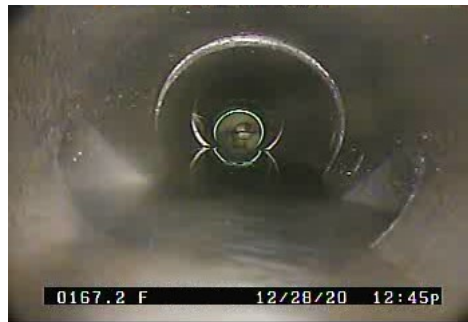
MH - Manhole @ 167.2 ft. Manhole  
S4048 ahead
