# City of Escanaba Wastewater System Improvements

Michigan Clean Water State Revolving Fund Project Plan (2023)  
Volume 2 – Appendix (FINAL)

22-0290

April 26, 2023

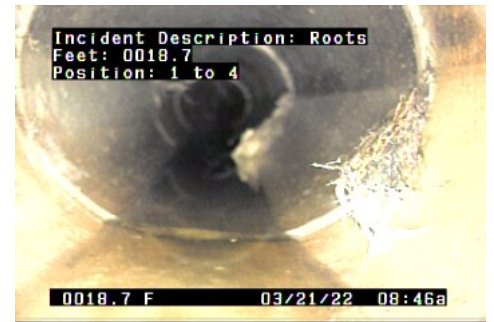
R - Roots @ 18.7 ft.

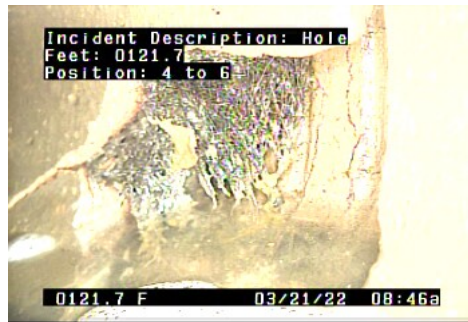
H - Hole @ 121.7 ft.

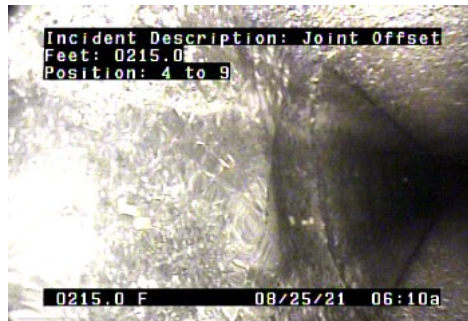
JO - Joint Offset @ 215.0 ft.

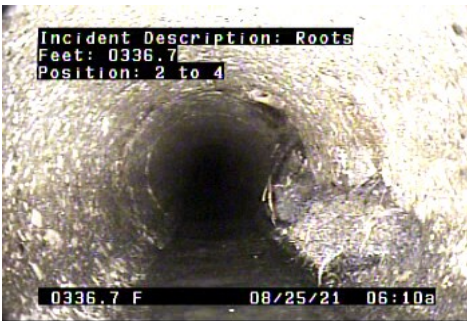
R - Roots @ 336.7 ft.

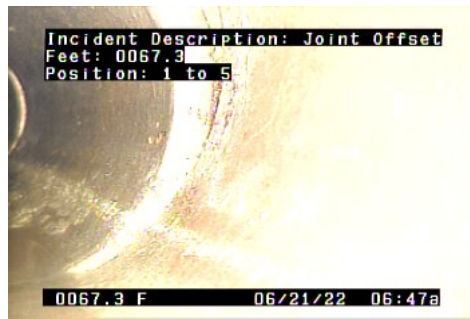
JO - Joint Offset @ 67.3 ft.

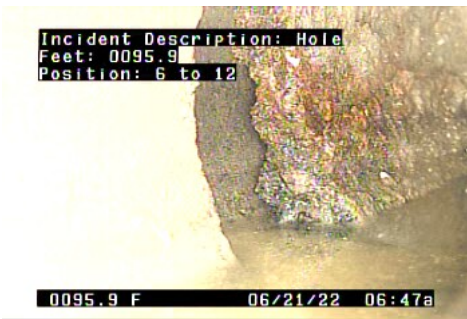
H - Hole @ 95.9 ft.

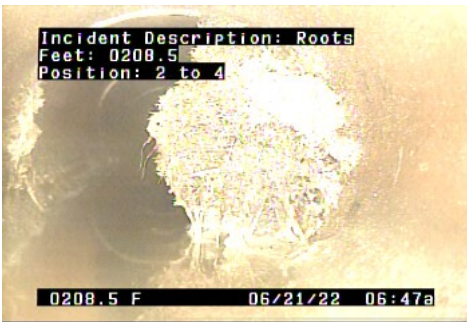
R - Roots @ 208.5 ft.

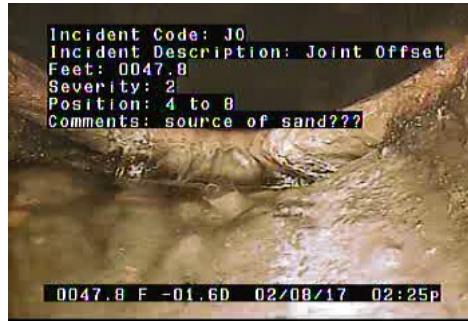
| <b>Comments</b><br>Possible clean sand | <b>Pre-Cleaning</b><br>No Pre-Cleaning | <b>TV Length</b><br>47.8 |

JO - Joint Offset @ 47.8 ft. source of sand???

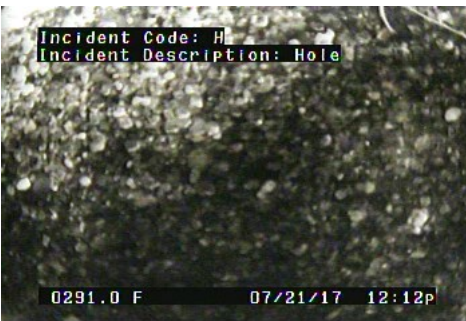
H - Hole @ 291.0 ft.

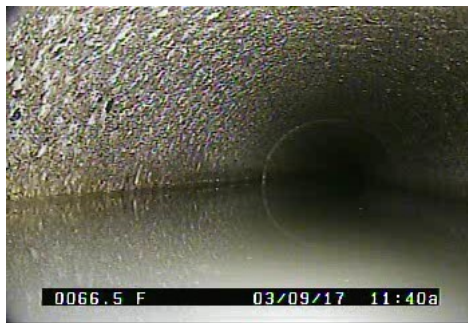
GO - General Observation @ 66.5 ft. stuck, end of survey

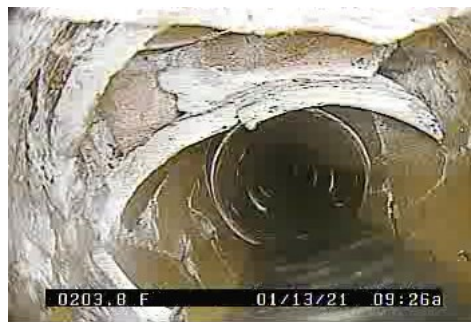
GO - General Observation @ 203.8 ft.

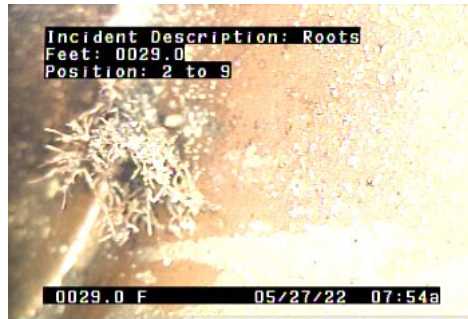
R - Roots @ 29.0 ft.

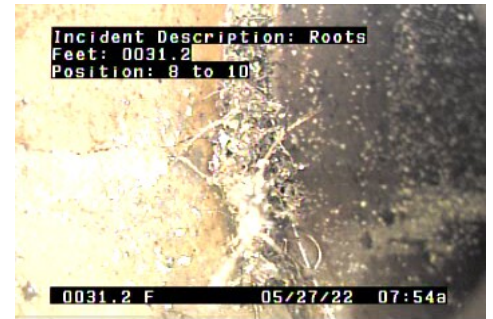
| | Ftg. | Code | Description | Position | Severity | Comment |
|--|---|---|---|---|---|--|
| | 31.2 | R | Roots | 8 to 10 | 3 | Large ball of roots. Likely the cause of the backups.<br>Roots are preventing the camera from advancing. |

R - Roots @ 31.2 ft.
